# Genesis Home Inspections, LLC

## Home Inspection Report

**123 S Main St**

Inspected on Wed, Oct 30 2024 at 9:00AM

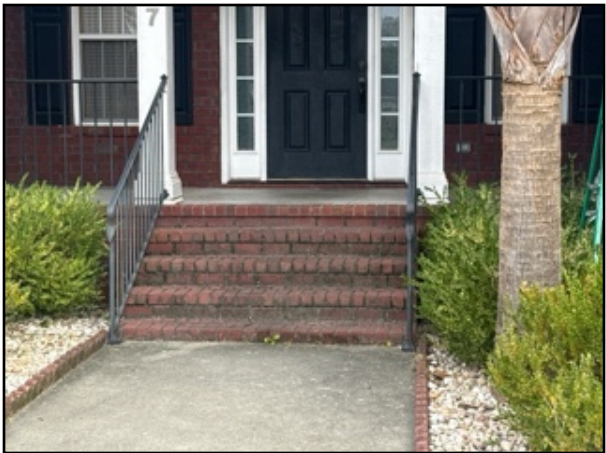
Figure 1-1

Comment 1:  
Loose handrails for entry steps to the home. Exterior front

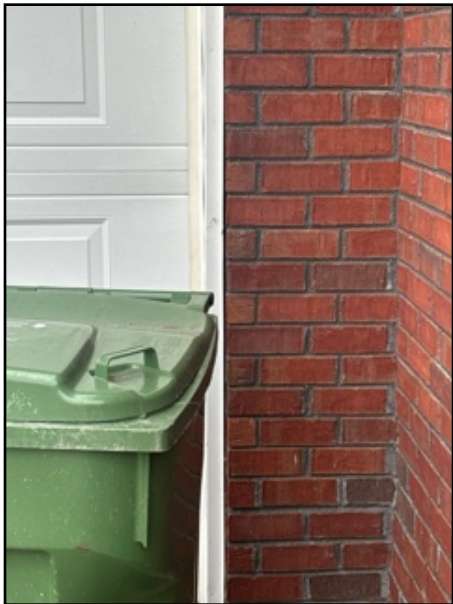
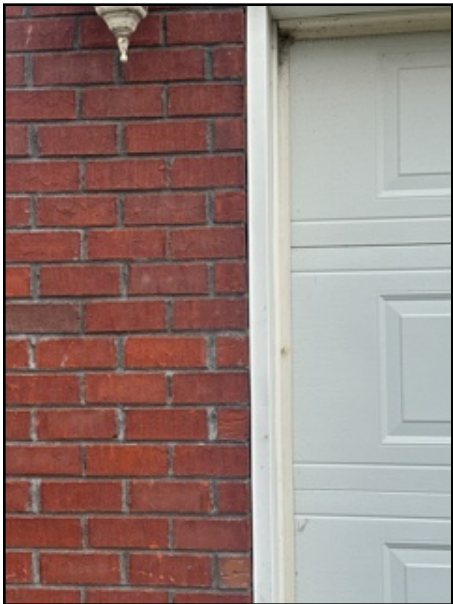
Figure 2-1

Comment 2:  
Exterior garage door trim is not sealed to the brick. Recommend sealing with clear silicone or an equivalent.

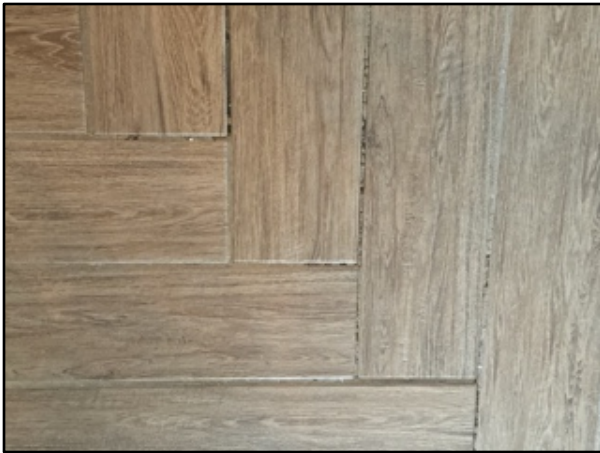
Figure 5-1

Damaged grout for the tile floors scattered inside the home.

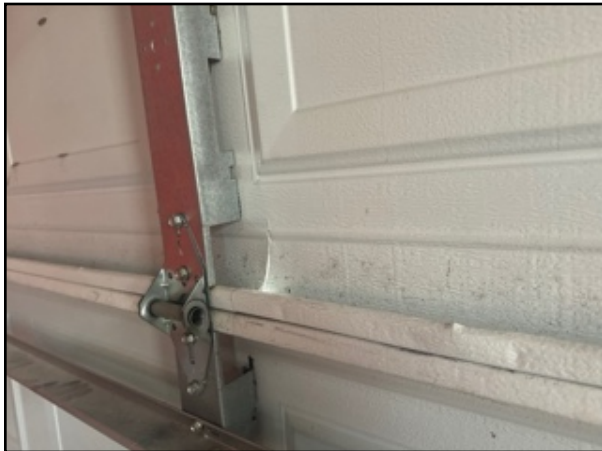
Figure 9-1

Damage to the panels of the garage door. The garage door does not go up fully. Recommend evaluation and repair by a licensed professional.

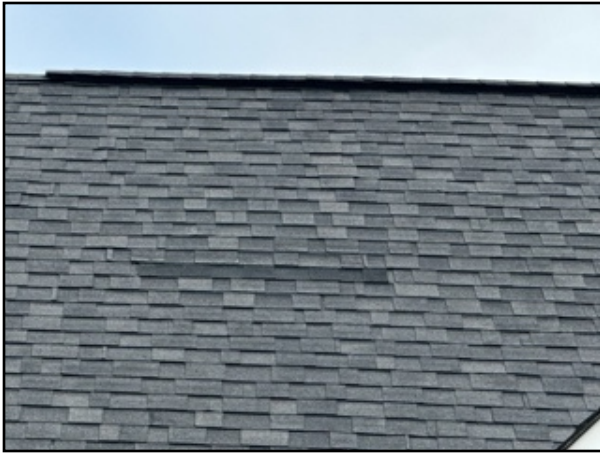
Figure 11-1

Shingles have been patched/replaced in spots on the roof of the home.

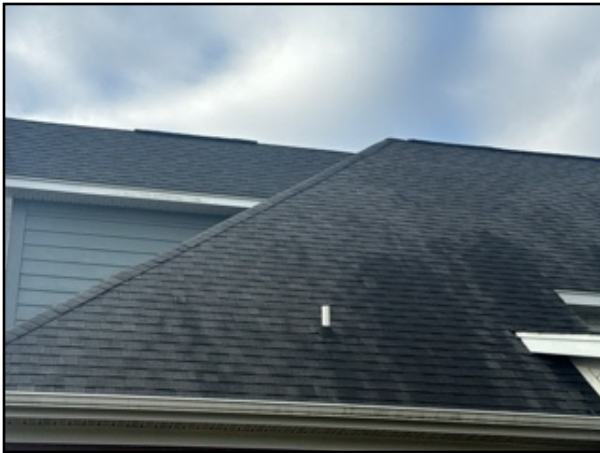
Figure 13-1

Heavy granulation loss to some shingles. The shingles are aged. Recommend evaluation by a licensed roofing contractor.

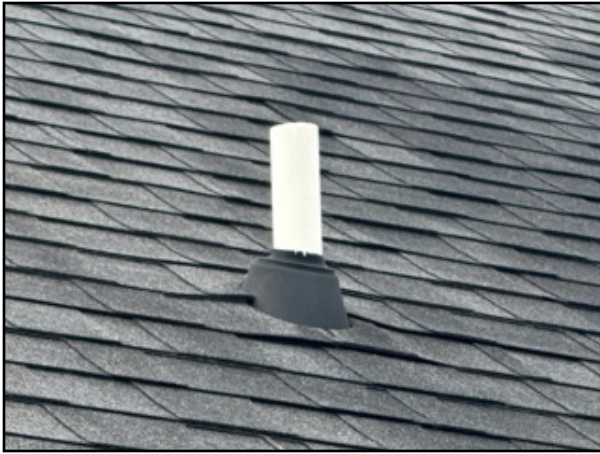
Figure 14-1

Comment 14:  
Damaged and cracking roof boots. Recommend replacing roof boots.

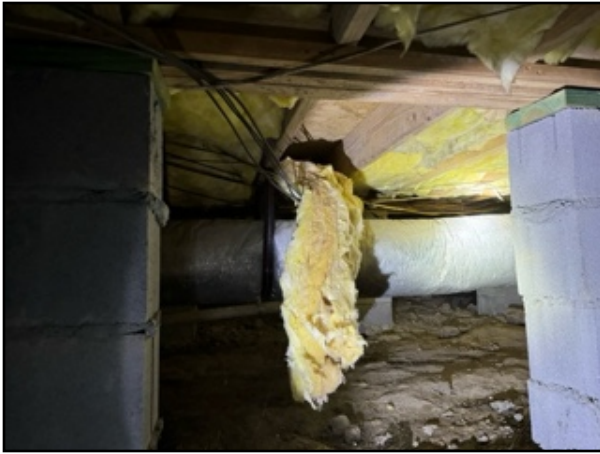
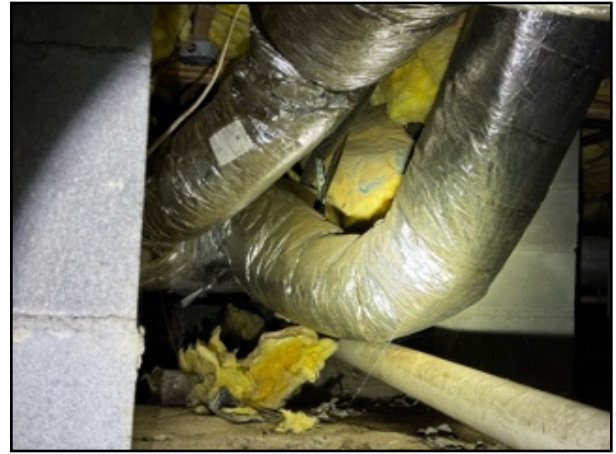
Figure 18-1

Falling and/or missing insulation in crawlspace of home.

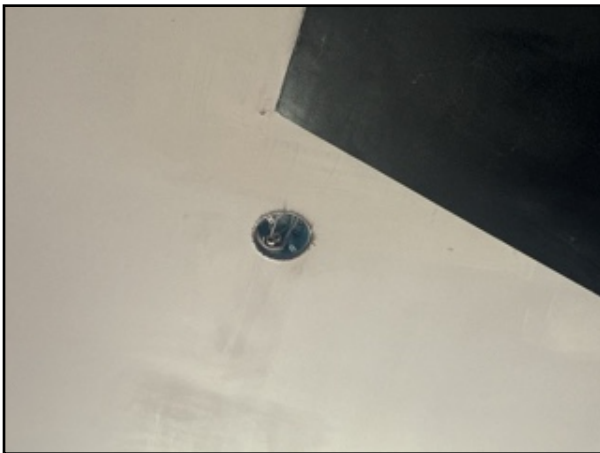
Figure 23-1

Open electrical wire in the garage ceiling. It appears the fixture is missing. Recommend installing a fixture.

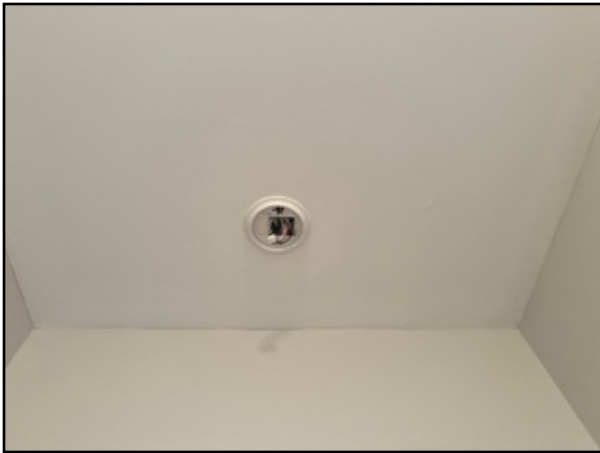
Figure 27-1

Smoke detectors missing from some bedrooms and hallways. Recommend installing smoke detectors where needed.

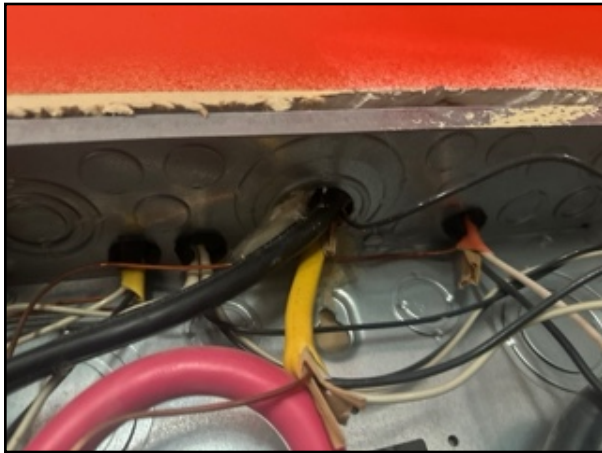
Figure 30-1

Electrical wires entering panel not protected by strain relief (romex connector). Recommend installing strain relief. Garage

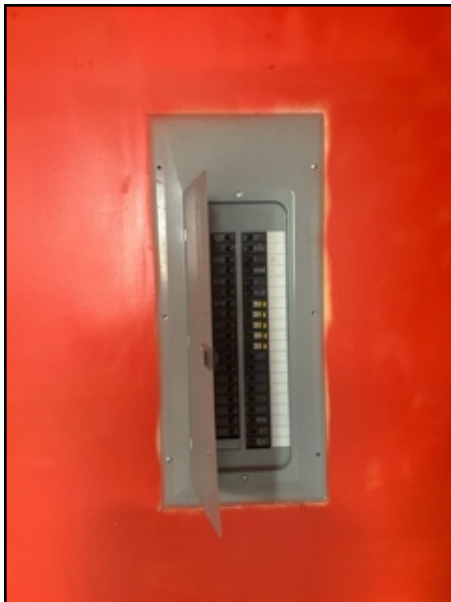
Figure 31-1

There are screws missing from panel cover. Recommend installing panel cover screws where needed. Garage

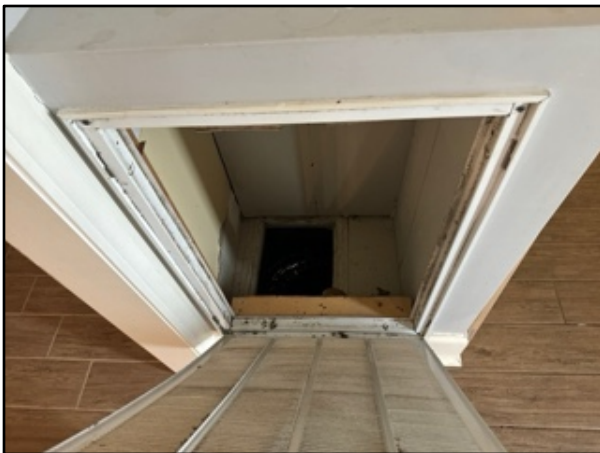
Figure 32-1

The HVAC air filter was missing at time of inspection. Recommend changing the filters monthly.

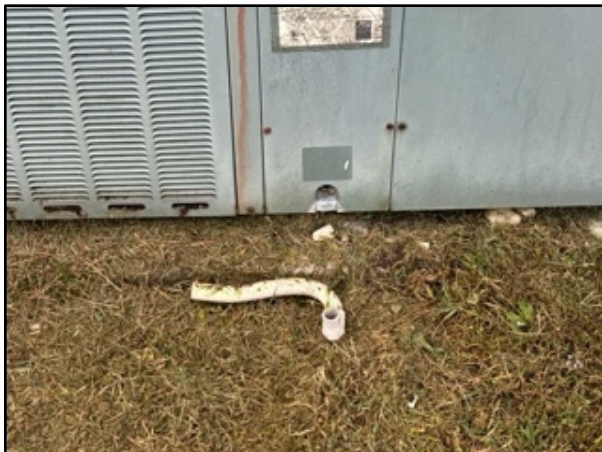
Figure 38-1

Damaged and/or missing drain line for the package HVAC unit. Exterior rear

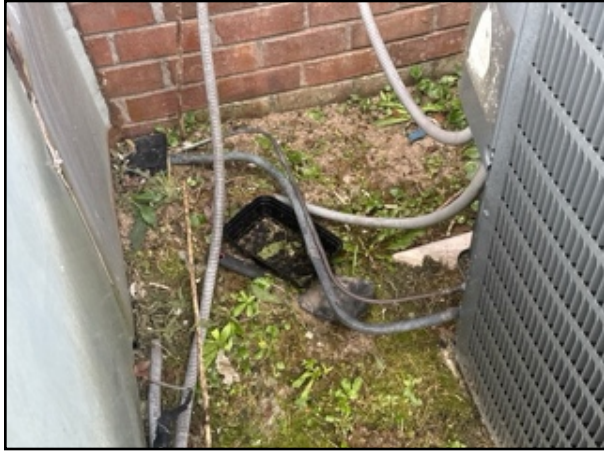
Figure 40-1

Damaged and/or missing pipe insulation for the refrigerant line to the HVAC unit.  
Exterior rear

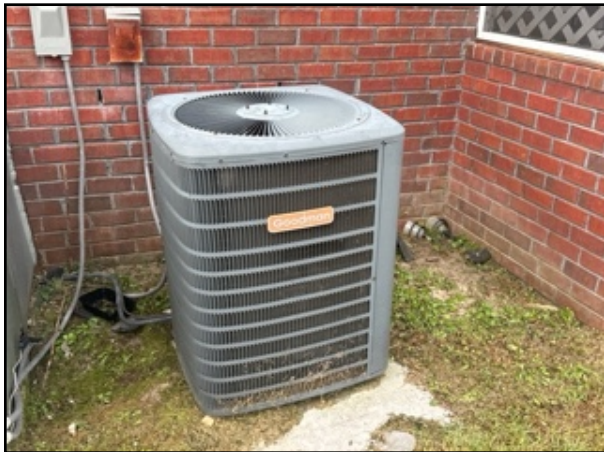
Figure 41-1

The average life span for HVAC unit is approximately 10-15 years. The HVAC unit for the home is nearing the end of the average life span and may need to be replaced at any point.

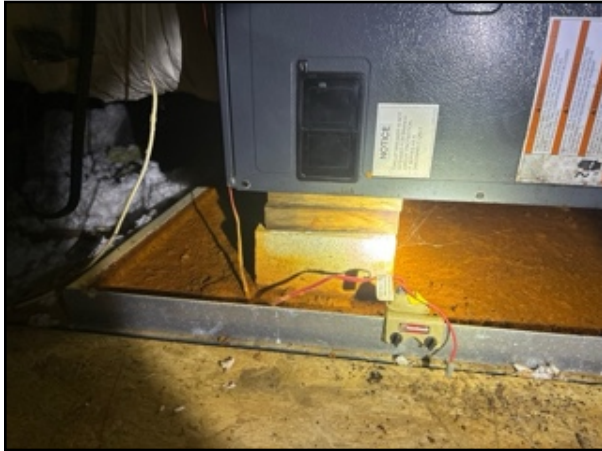
Figure 42-1

Drain pan for the air handler in the attic had heavy rust. Recommend evaluation and repair if necessary by a licensed HVAC contractor. Upper attic

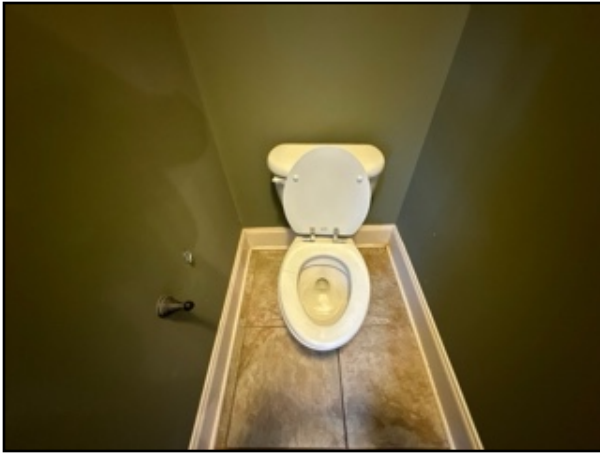
Figure 46-1

The toilet was loose from the floor at the time of inspection. Recommend securing the toilet to the floor and ensuring the toilet is leak free. Primary and half bathroom

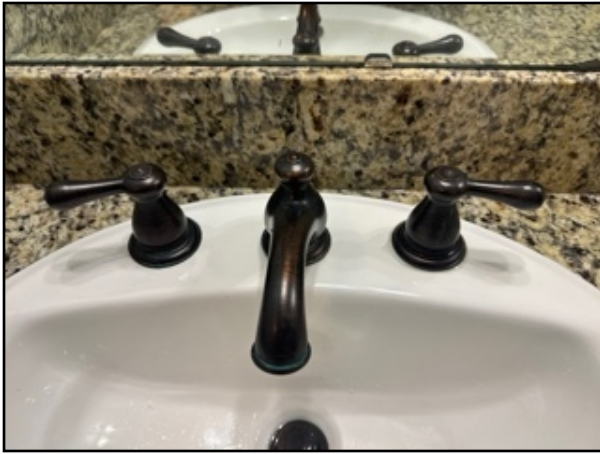
Figure 48-1

Sink faucet leaks from base and/or handles. Hallway bathroom

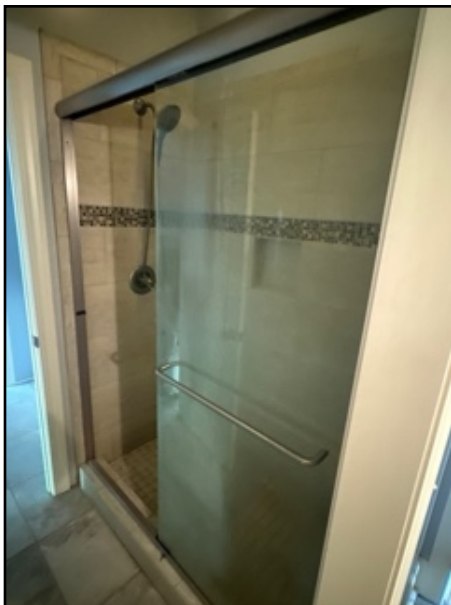
Figure 51-1

There is one door missing for the tile shower. Upstairs right bathroom

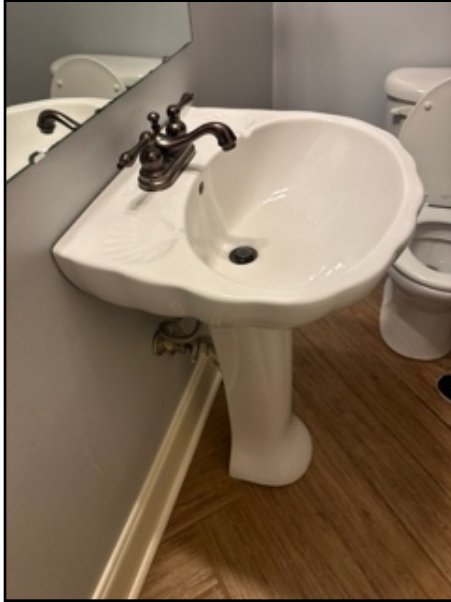
Figure 52-1

Pedestal sink is loose from the wall. Recommend securing to the wall. Upstairs left bathroom

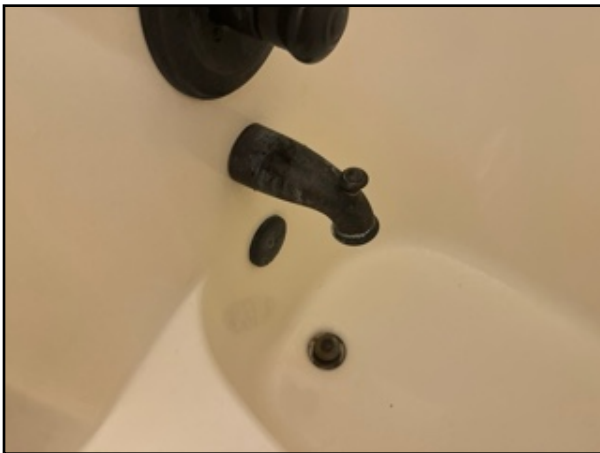
Figure 53-1

The tub spout is not sealed to the shower wall. Recommend sealing to prevent moisture penetration behind the tub spout. Upstairs left bathroom

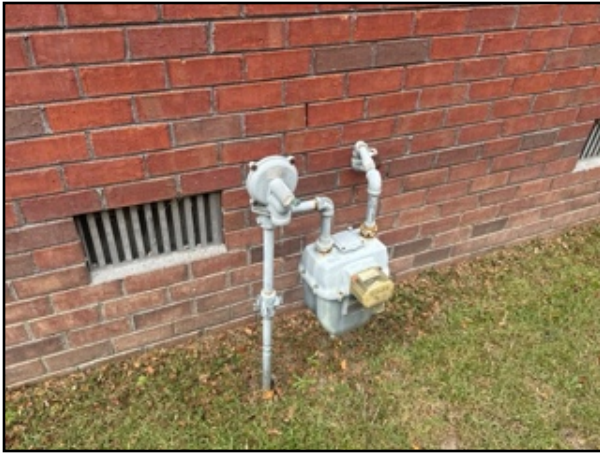
Figure 56-1

Main gas shutoff located by the gas meter on the exterior right side of home.

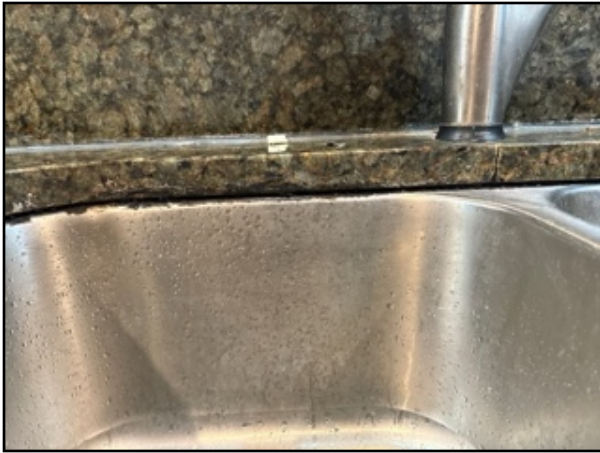
Figure 63-1

The kitchen sink is not secured to the countertop properly and was loose from the countertop. The sink was not sealed to the countertop. Recommend securing and sealing the sink to the countertop.

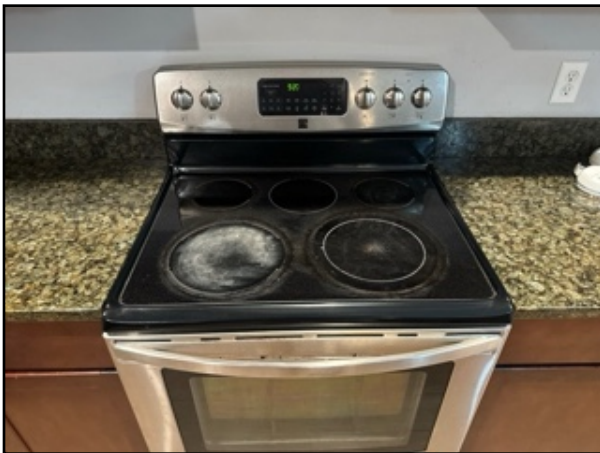
Figure 65-1

No anti-tip bracket installed for range at time of inspection. Recommend installing anti-tip bracket.

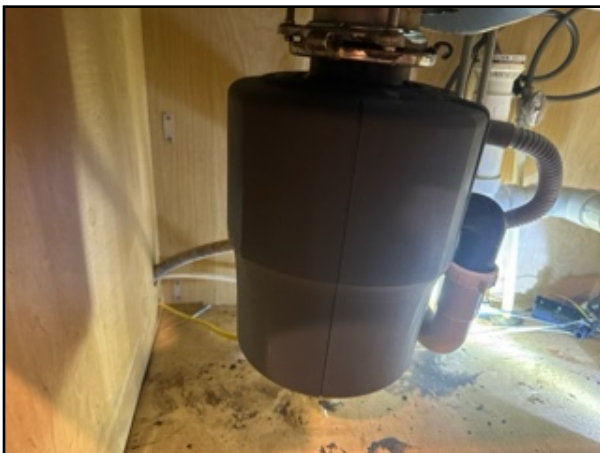
Figure 67-1

There was no visible elevated drip loop for the dishwasher drain line under the kitchen sink. Recommend installing an elevated drip loop for the dishwasher drain line.

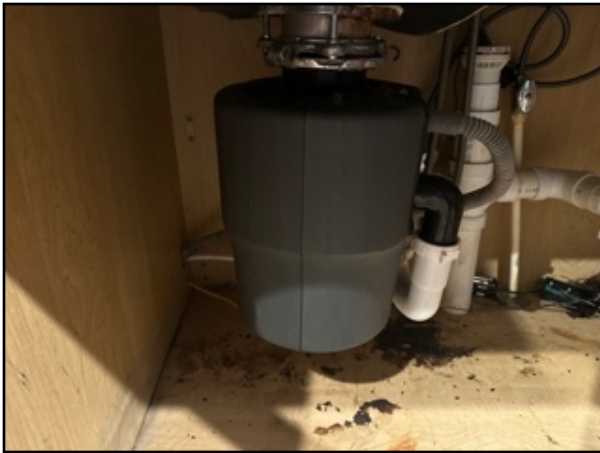
Figure 68-1

A foreign object was in the disposal at the time of inspection. Recommend removal of the foreign object.

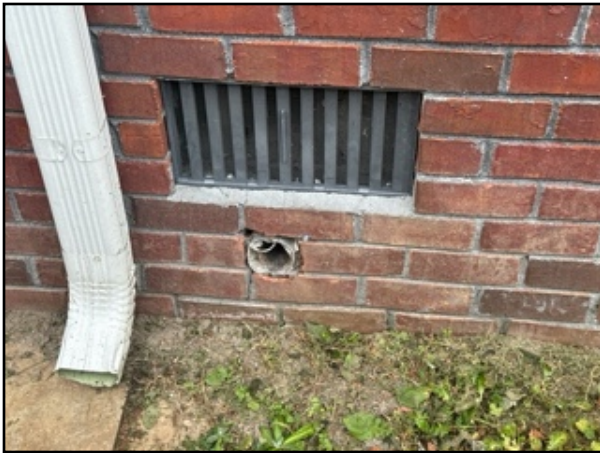
Figure 69-1

Exterior dryer vent hood is damaged and/or missing. Recommend installing an exterior dryer vent hood. Exterior left side

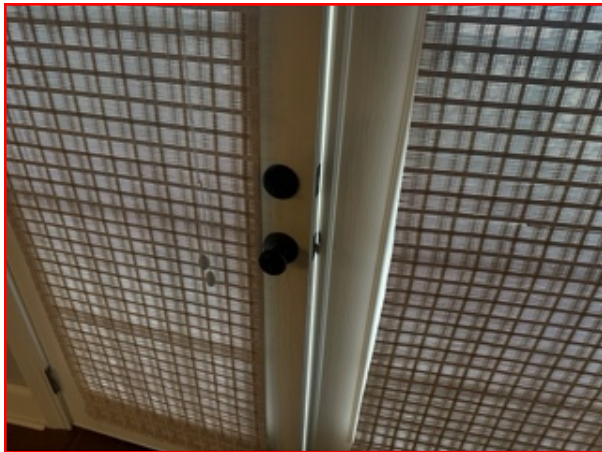
Figure 3-1

3) Comment 3: Entry door does not latch when the door is being closed. Door and/or hardware may need adjustment. Exterior rear

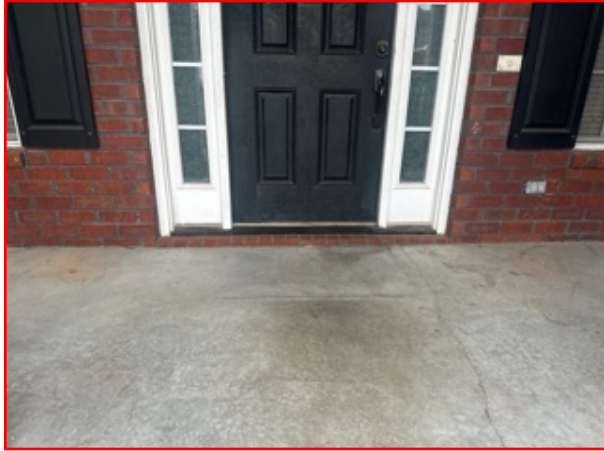
Figure 4-1

4) Comment 4: Threshold for the entry door was not sealed with silicone or an equivalent on exterior. Recommend sealing to prevent moisture penetration. Exterior front

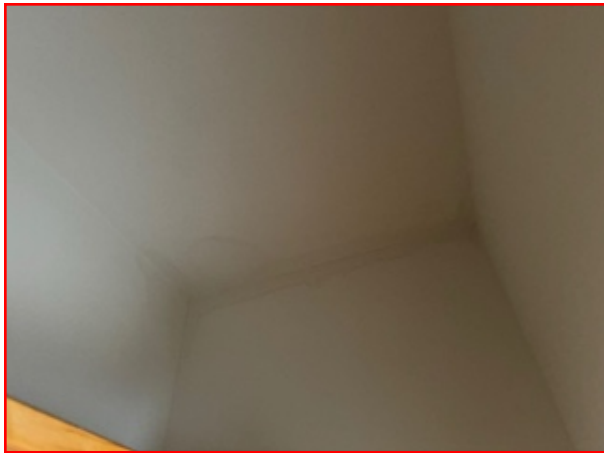
Figure 6-1

6) Comment 6: Scattered moisture staining to ceilings and walls. Not wet at time of inspection. Recommend further evaluation by a licensed contractor.

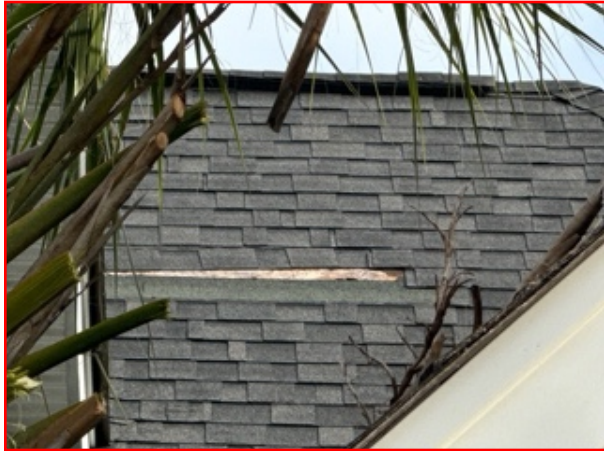
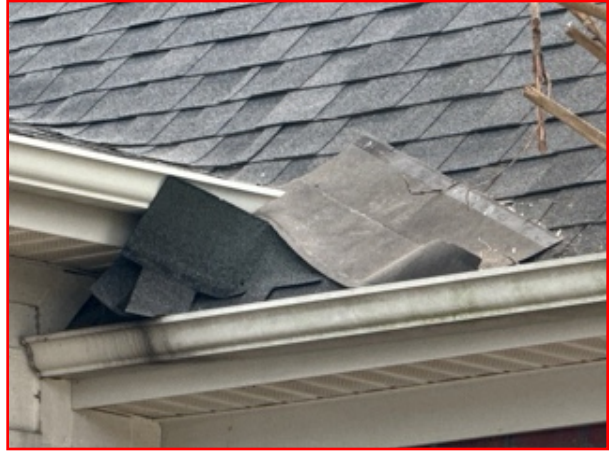
Figure 10-1

8) Comment 10: Damaged, loose, and/or missing shingles on the roof of the home. There is an area of exposed roof sheathing. Possible hidden damage.

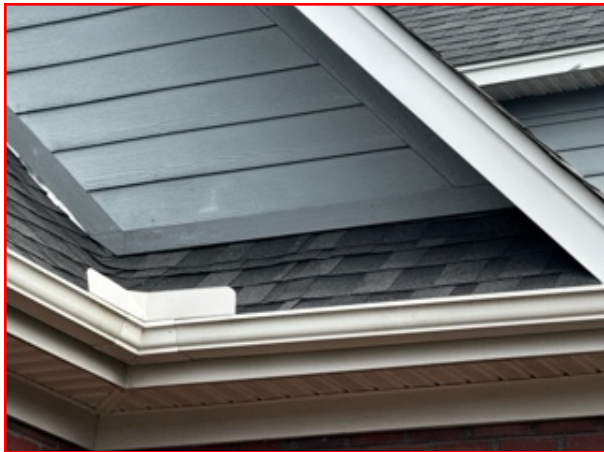
Figure 12-1

9) Comment 12: Shingle with exposed nail heads. Recommend sealing over the nail hole to prevent moisture penetration.

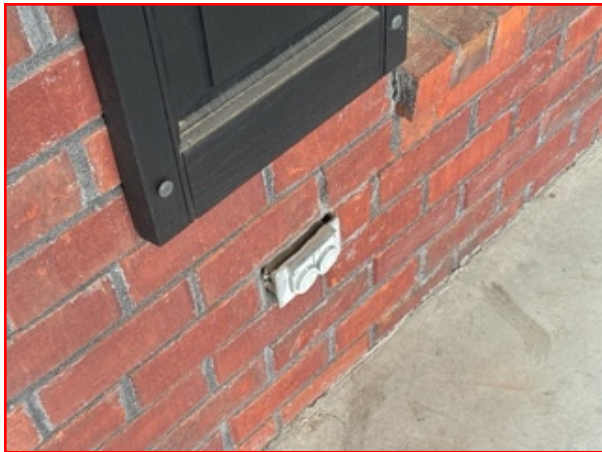
Figure 24-1

17) Comment 24: Loose receptacles. Not secured to work box or the work box is not secured. Recommend securing the receptacles. Exterior front

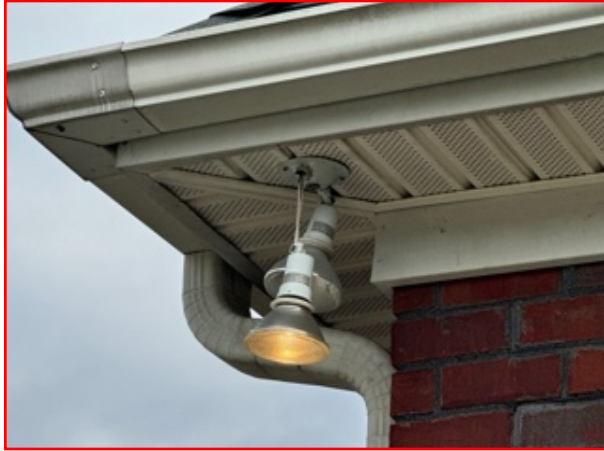
Figure 25-1

18) Comment 25: Damaged light fixture with exposed electrical wire. Exterior front

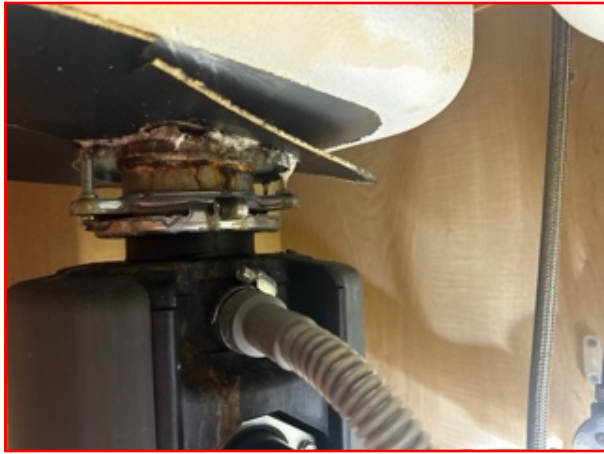
Figure 43-1

29) Comment 43: Active plumbing leak in sink base cabinet.

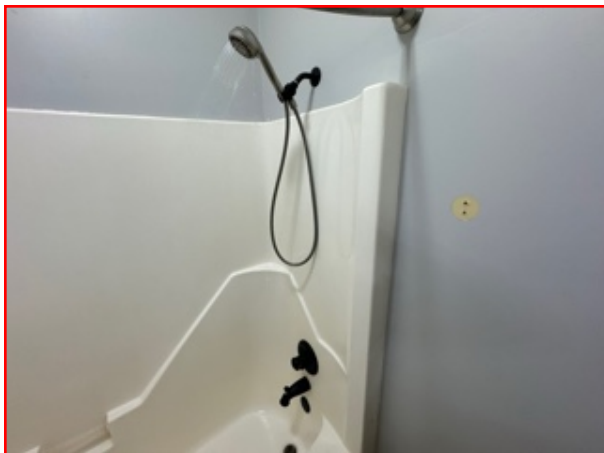
Figure 44-1

30) Comment 44: Hammering water lines in the wall when hallway bathroom shower is in use.

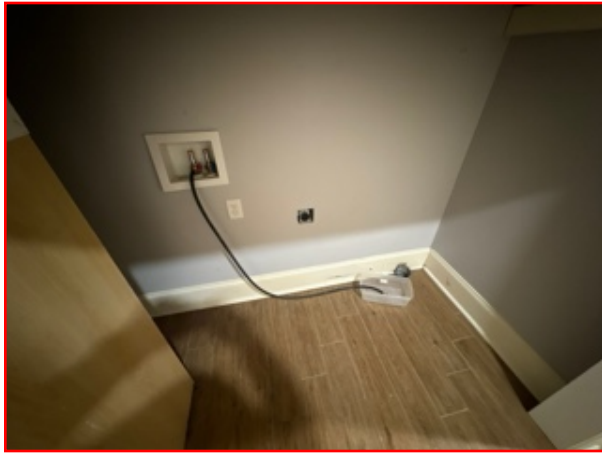
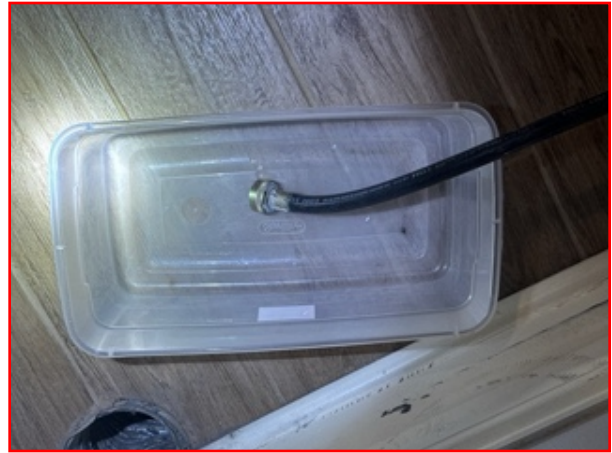
Figure 45-1

31) Comment 45: Washing machine water valves leaking at the time of inspection.

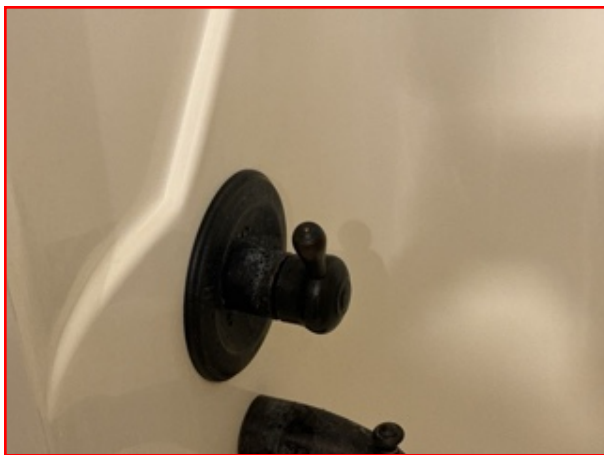
Figure 54-1

40) Comment 54: The shower valve is not functioning properly. Possibly a valve or handle issue. Upstairs left bathroom

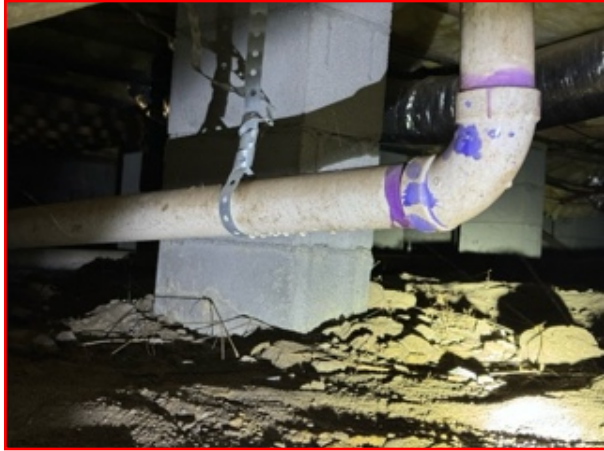
Figure 55-1

41) Comment 55: Active leak from a drain line under the kitchen area in the crawlspace.

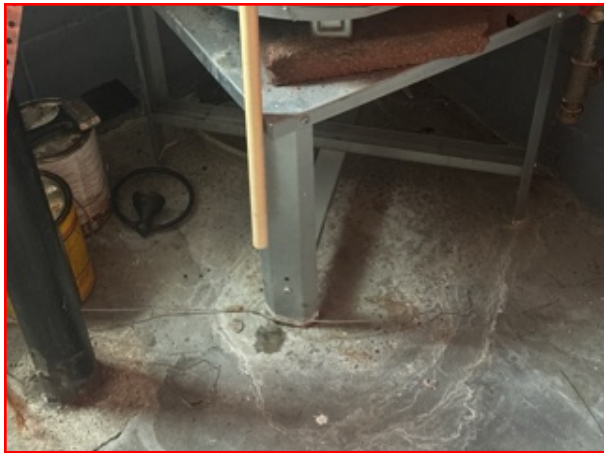
Figure 57-1

42) Comment 57: The T&P valve piping for the hot water heater was leaking indicating a valve issue. Garage

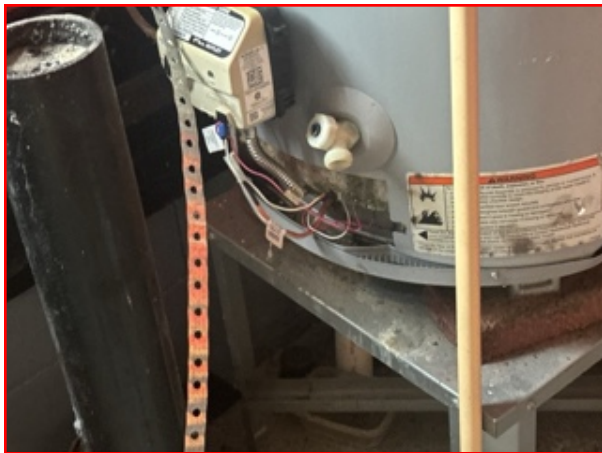
Figure 59-1

44) Comment 59: There is a cover plate missing for the water heater. Garage

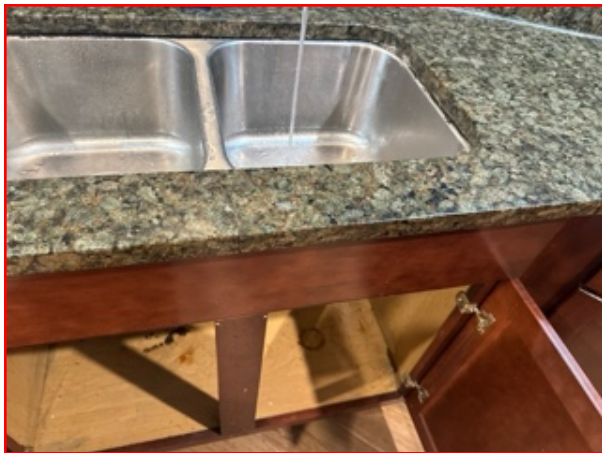
Figure 62-1

46) Comment 62: The granite counter is loose from the cabinets. Kitchen
