# Genesis Home Inspections, LLC

## Home Inspection Report

**123 S Main St**

Inspected on Wed, Oct 30 2024 at 9:00AM

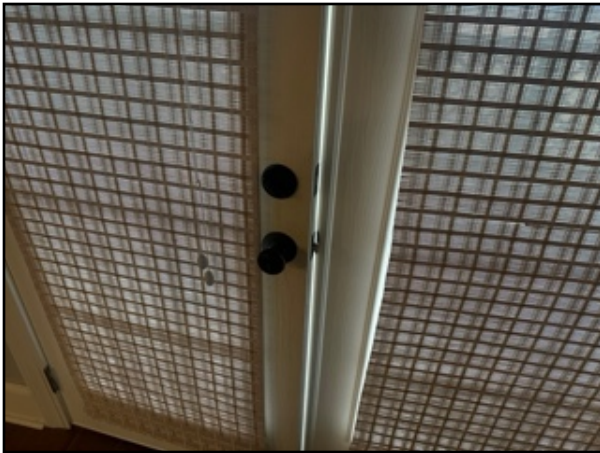
Figure 3-1

Entry door does not latch when the door is being closed. Door and/or hardware may need adjustment. Exterior rear

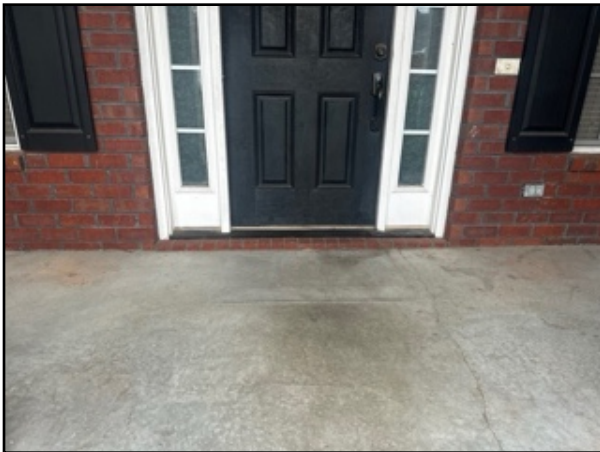
Figure 4-1

Threshold for the entry door was not sealed with silicone or an equivalent on exterior. Recommend sealing to prevent moisture penetration. Exterior front

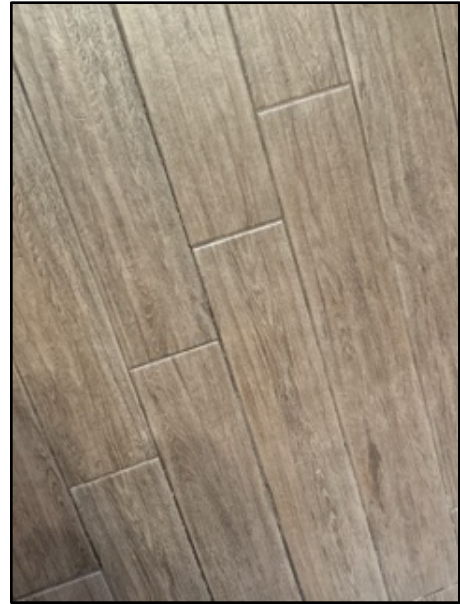
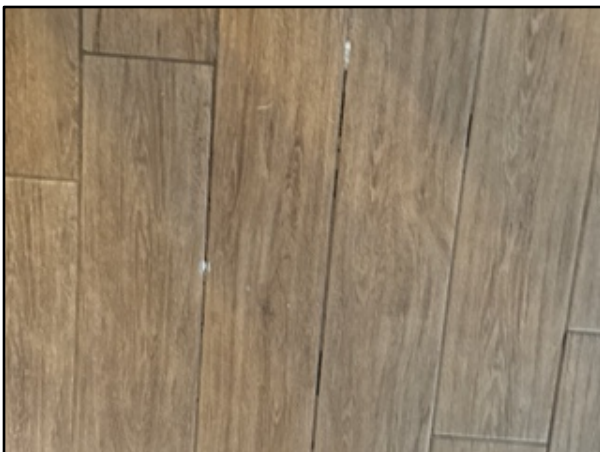
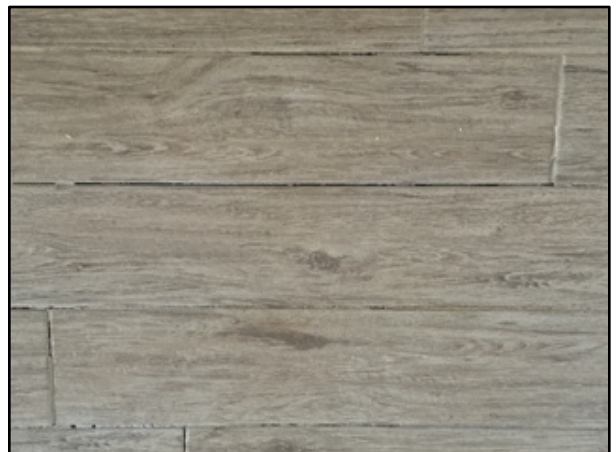
Damaged grout for the tile floors scattered inside the home.

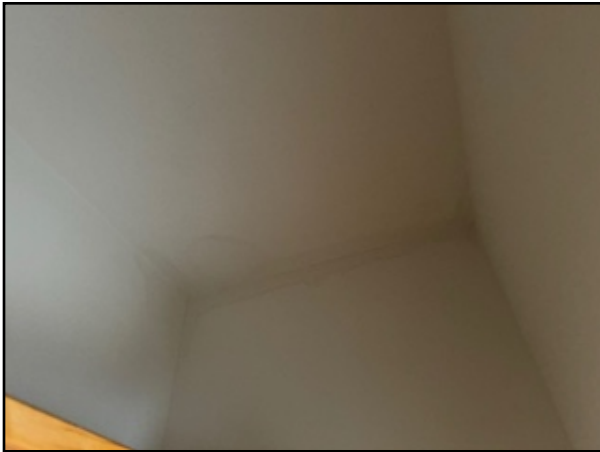
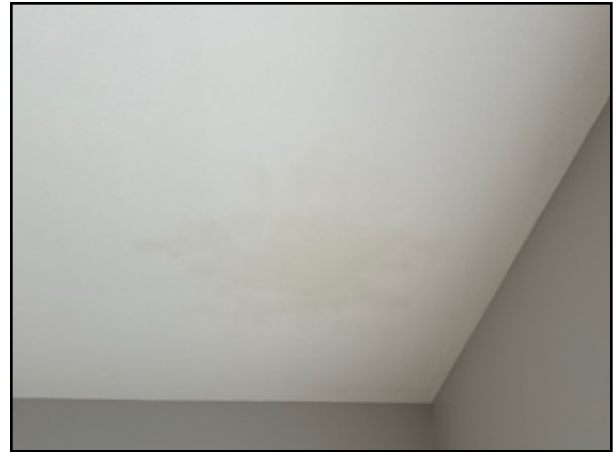
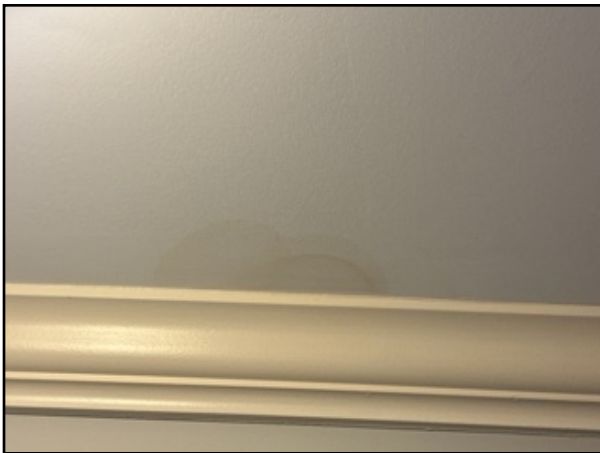
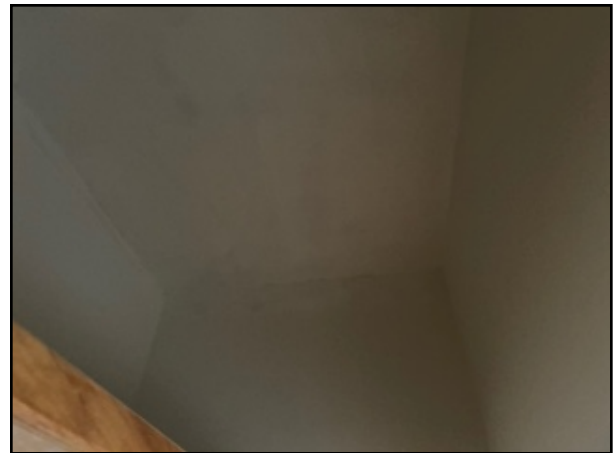
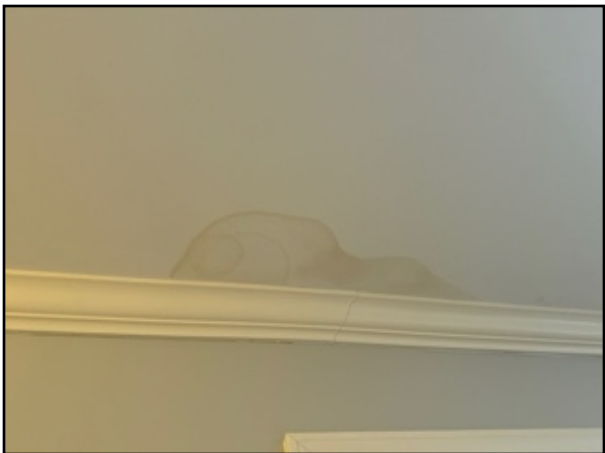
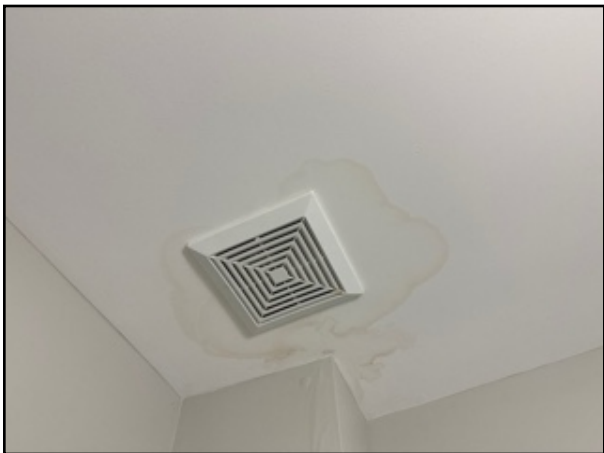
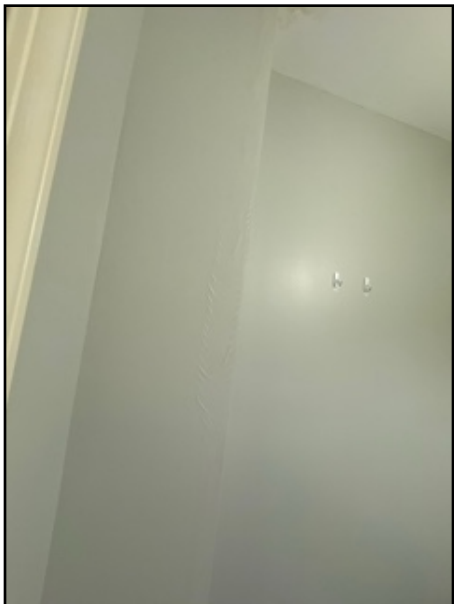
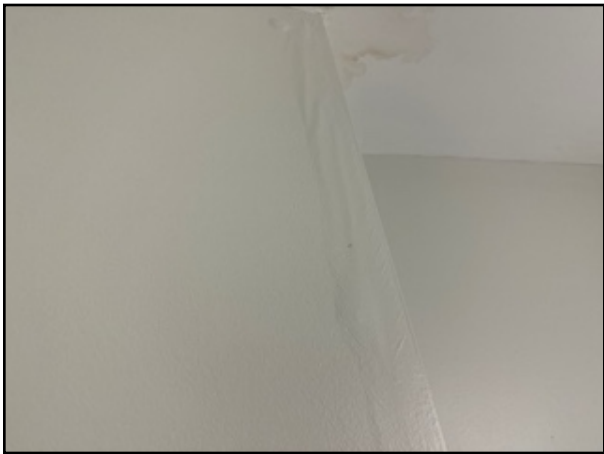
Scattered moisture staining to ceilings and walls. Not wet at time of inspection. Recommend further evaluation by a licensed contractor.

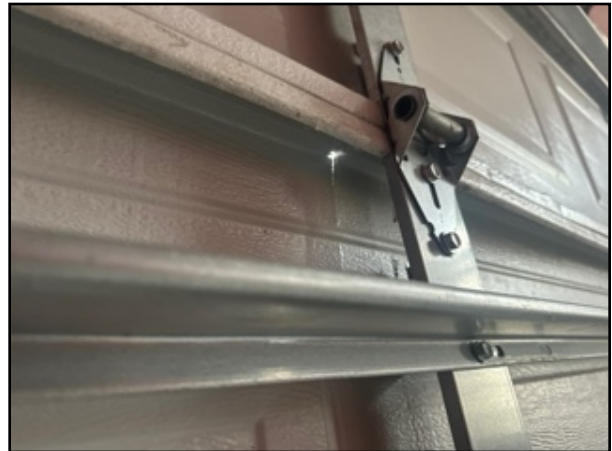
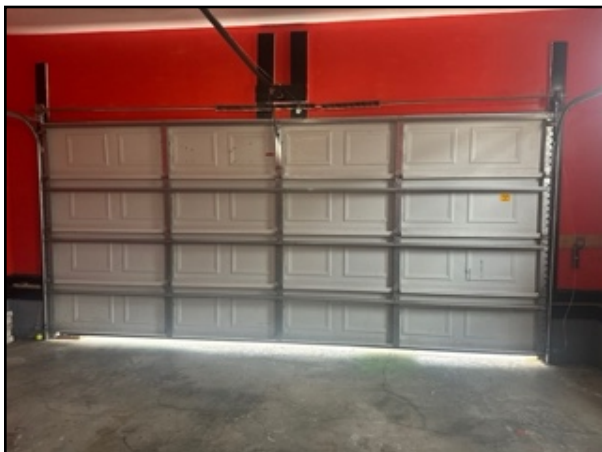
Comment 8:  
I was unable to check the door safety features due to the damage to the garage door.

Damage to the panels of the garage door. The garage door does not go up fully. Recommend evaluation and repair by a licensed professional.

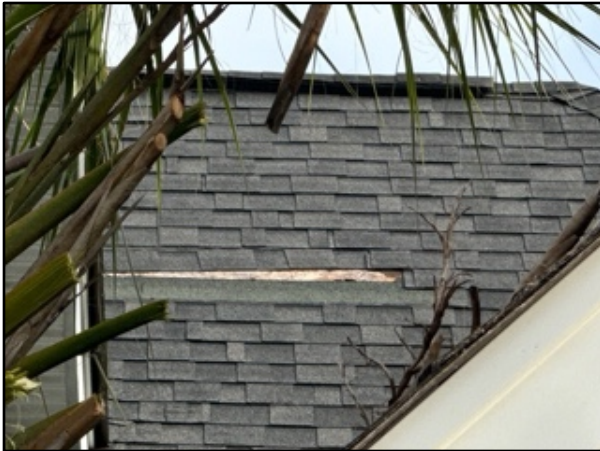
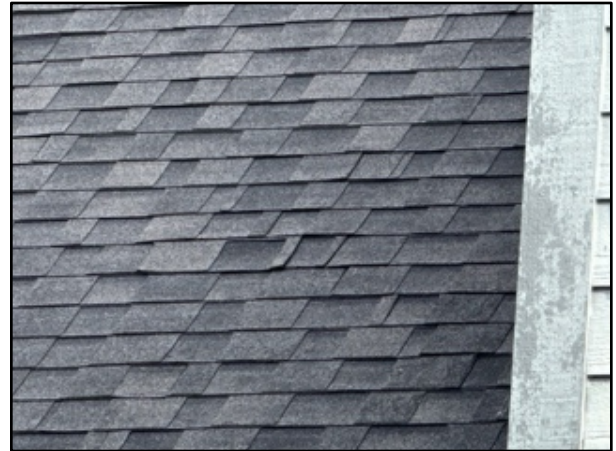
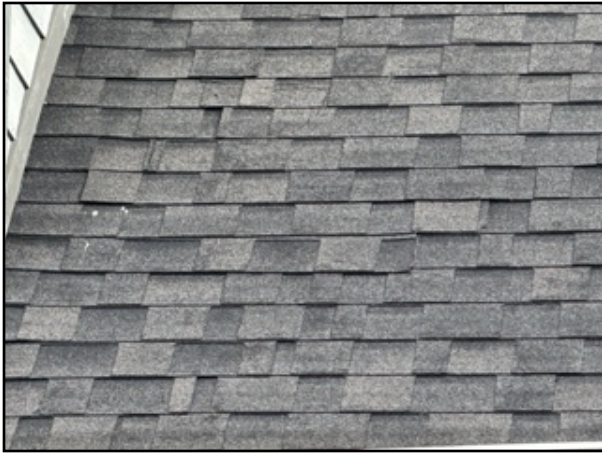
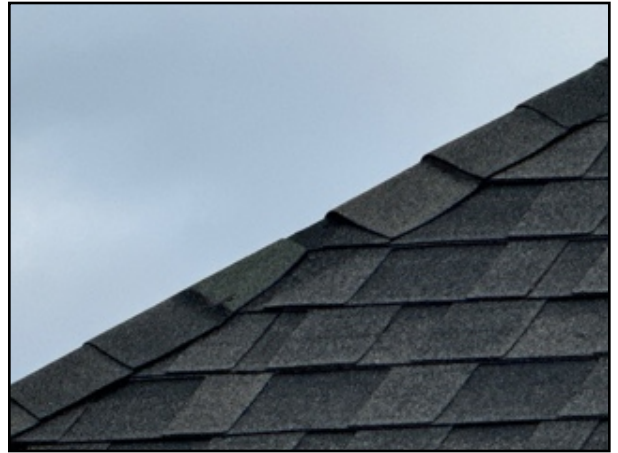
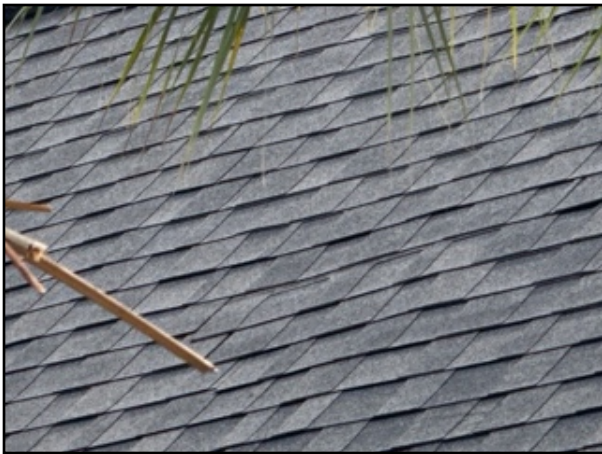
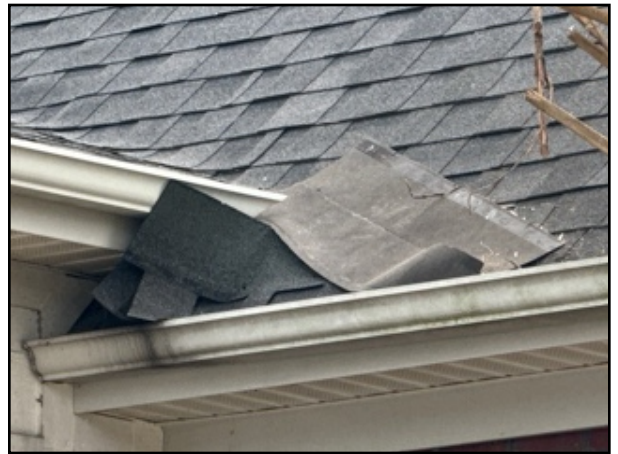
Damaged, loose, and/or missing shingles on the roof of the home. There is an area of exposed roof sheathing. Possible hidden damage.

Comment 15:  
Due to the age and amount of issues with the roof I recommend a full evaluation of the roof by a licensed contractor and repair or replace accordingly.

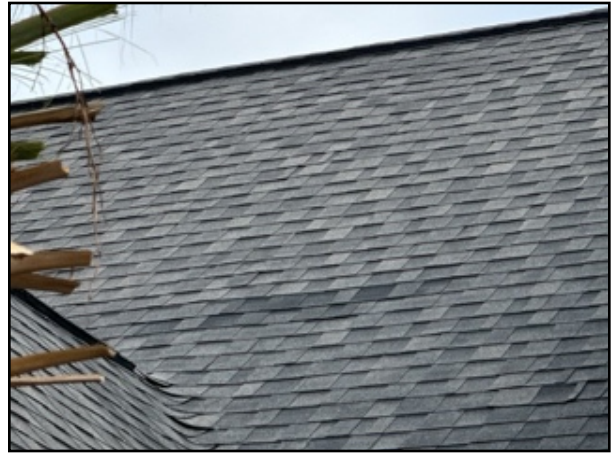
Figure 11-2

Shingles have been patched/replaced in spots on the roof of the home.

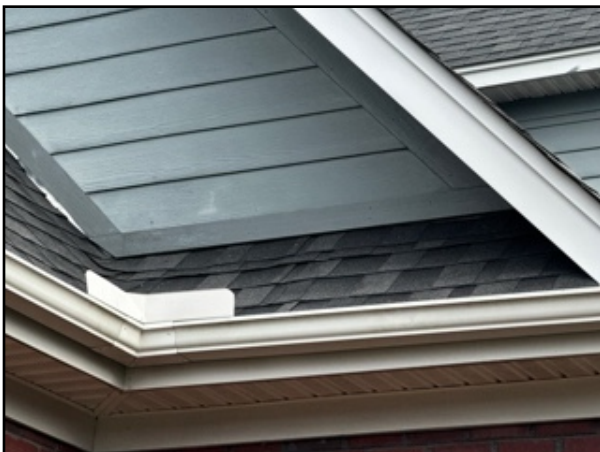
Figure 12-1

Shingle with exposed nail heads. Recommend sealing over the nail hole to prevent moisture penetration.

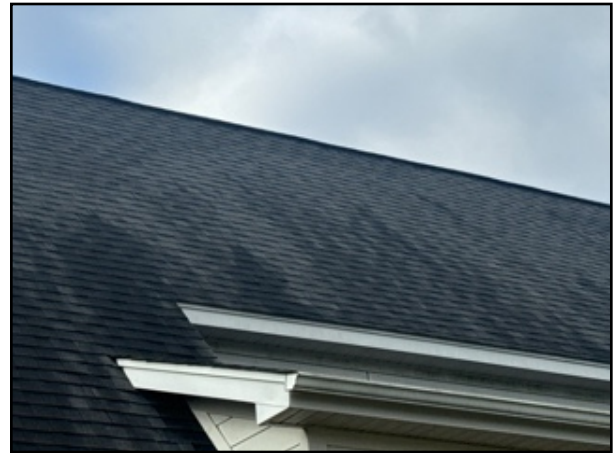
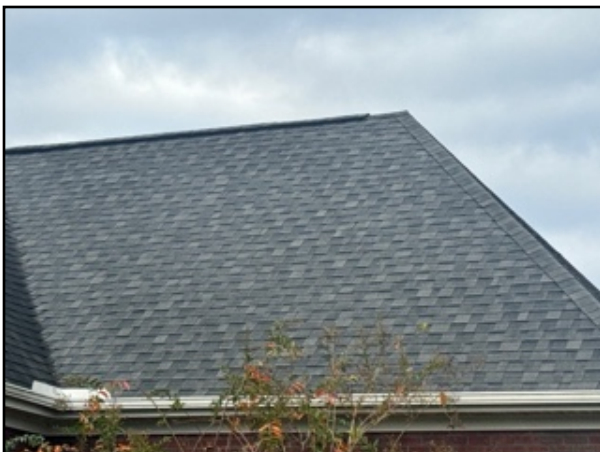
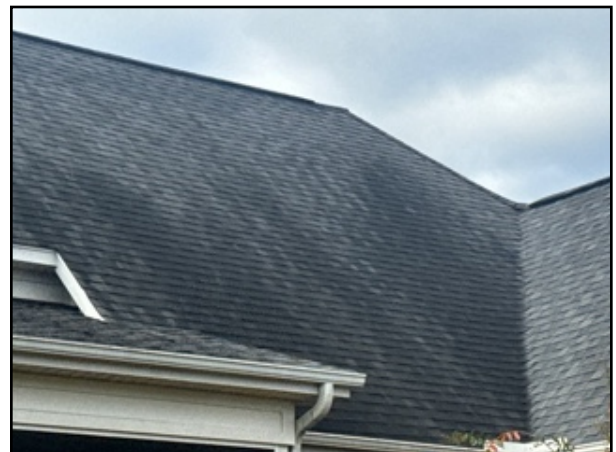
Heavy granulation loss to some shingles. The shingles are aged. Recommend evaluation by a licensed roofing contractor.

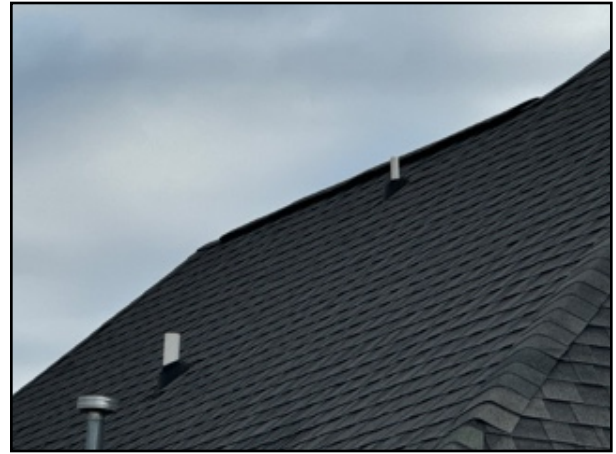
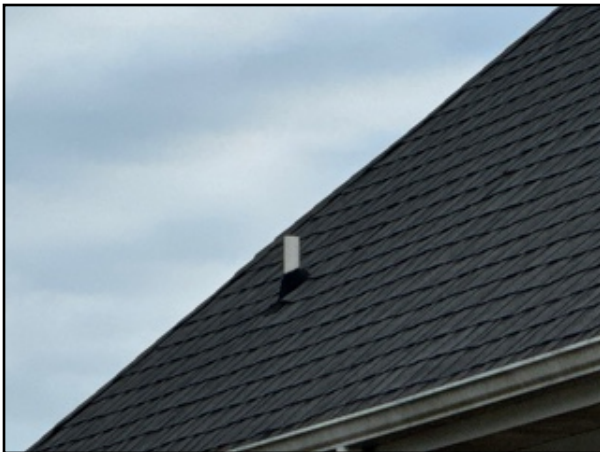
Comment 14:  
Damaged and cracking roof boots. Recommend replacing roof boots.

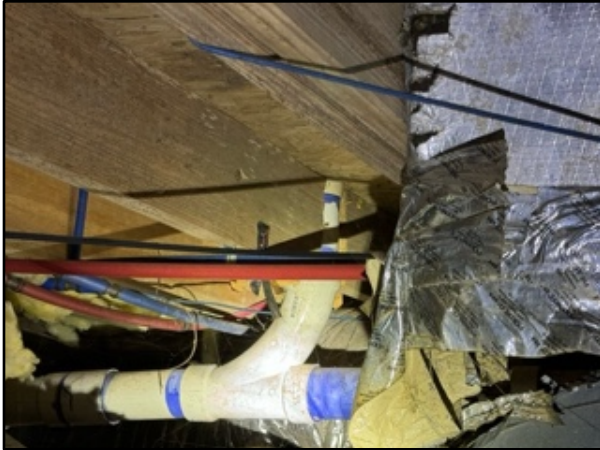
Figure 16-1

There is a cut floor joist without repairs in the crawlspace of the home. Recommend evaluation and repair by a licensed contractor. Right center area in the crawlspace.

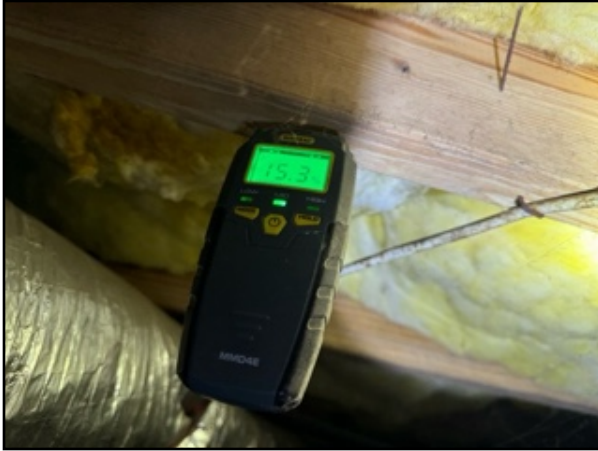
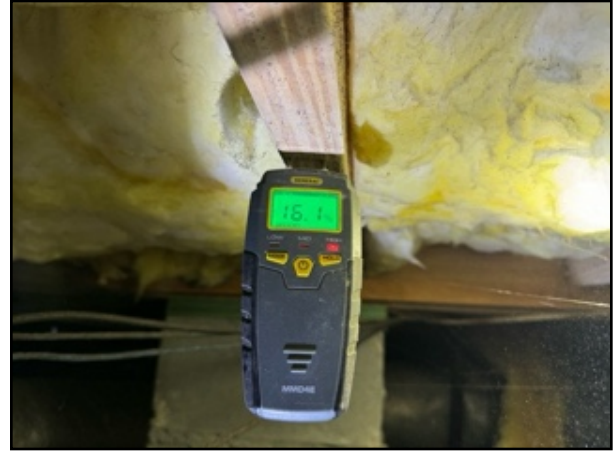
Moisture reading in the crawlspace of the home were between 15% and 17% at the time of inspection. For more information on moisture in the crawlspace please refer to the CL-100 done by others.

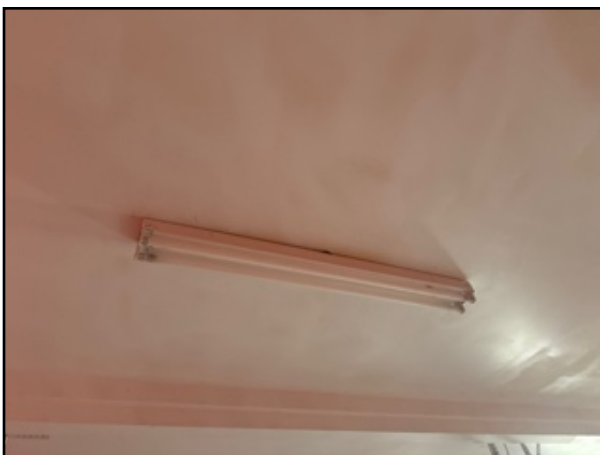
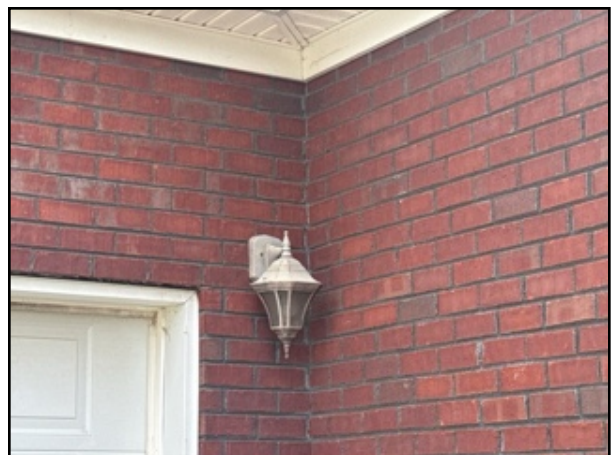
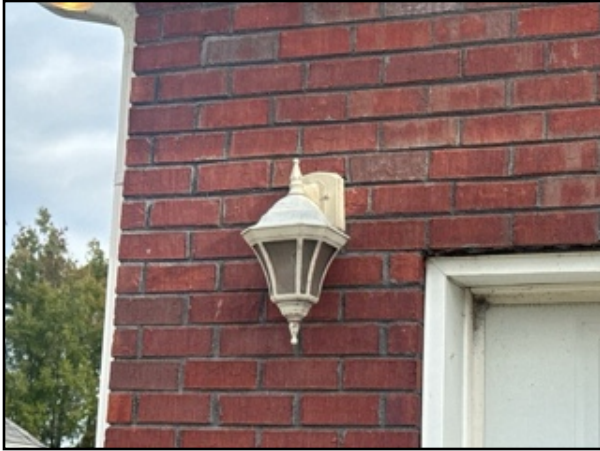
Light fixture non-functional at time of inspection. New bulbs may needed.  
Garage and exterior

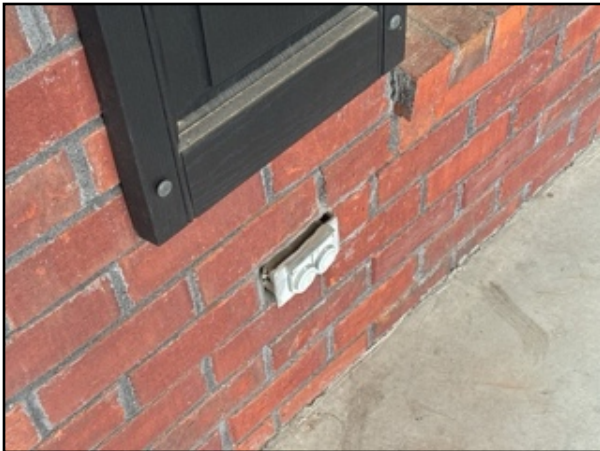
Figure 24-1

Loose receptacles. Not secured to work box or the work box is not secured. Recommend securing the receptacles. Exterior front

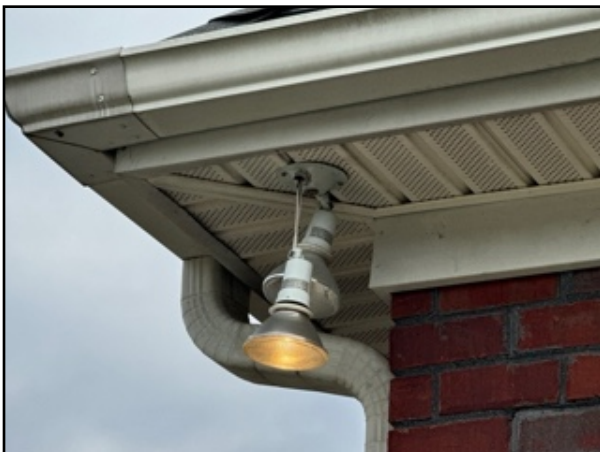
Figure 25-1

Damaged light fixture with exposed electrical wire. Exterior front

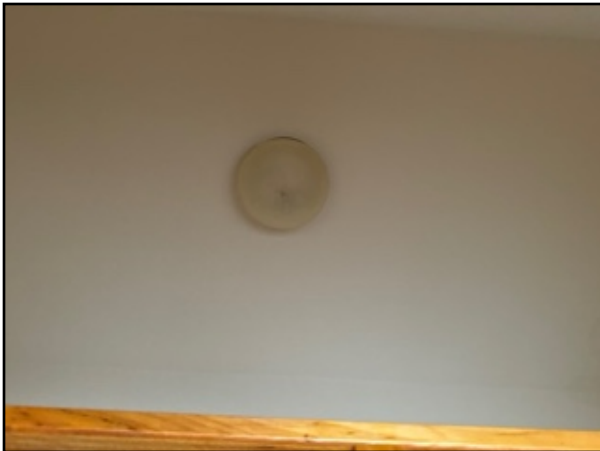
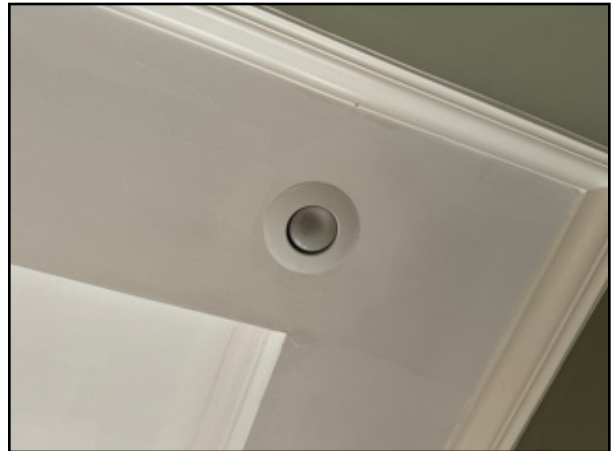
Light fixture non-functional at time of inspection. New bulbs may needed. Right center bedroom closet and primary bedroom

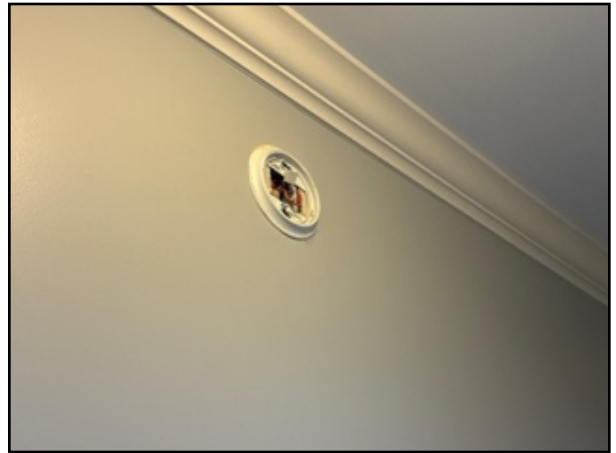
Figure 27-2

Smoke detectors missing from some bedrooms and hallways. Recommend installing smoke detectors where needed.

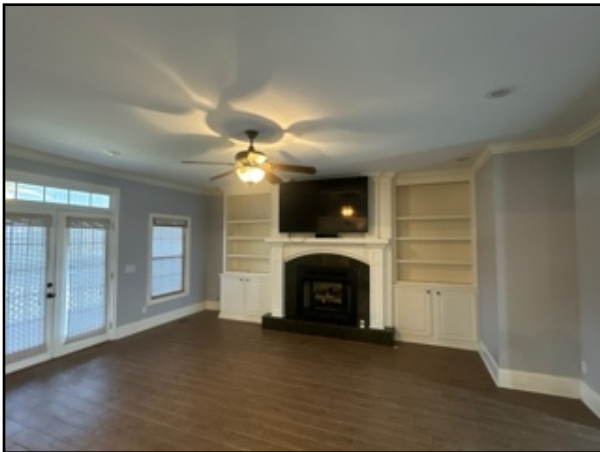
Figure 28-1

There are gas appliances in the home and there is not a carbon monoxide detector present. Recommend installing a carbon monoxide detector.

For all items mentioned in this section of the report I recommend evaluation and repair by a licensed electrical contractor.

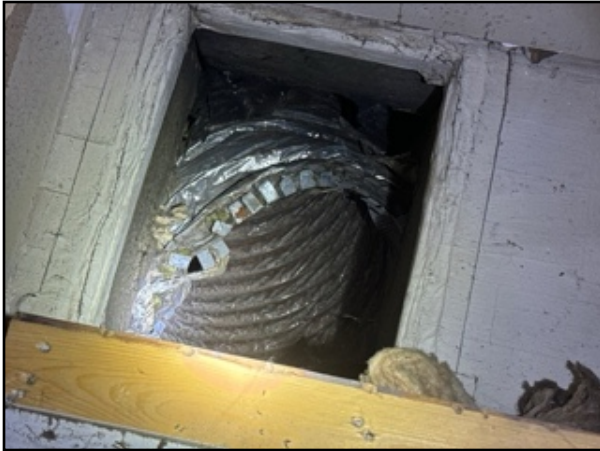
Figure 33-1

The return duct for the package unit was disconnected in the crawlspace of the home.

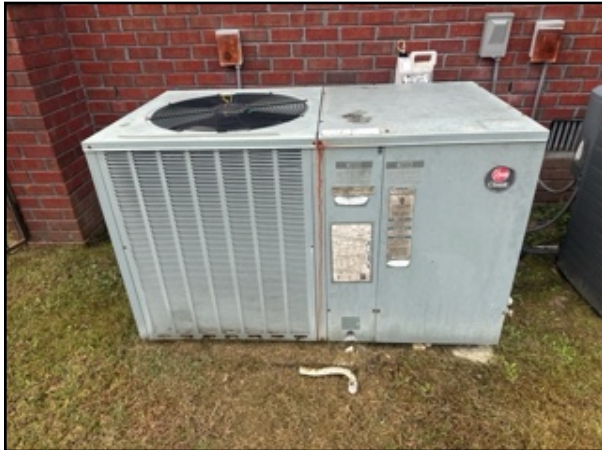
Figure 39-1

The average life span for HVAC units is approximately 10-15 years. The unit has well surpassed the average life span and may need to be replaced at any point. Recommend evaluation by a licensed HVAC contractor before purchase.

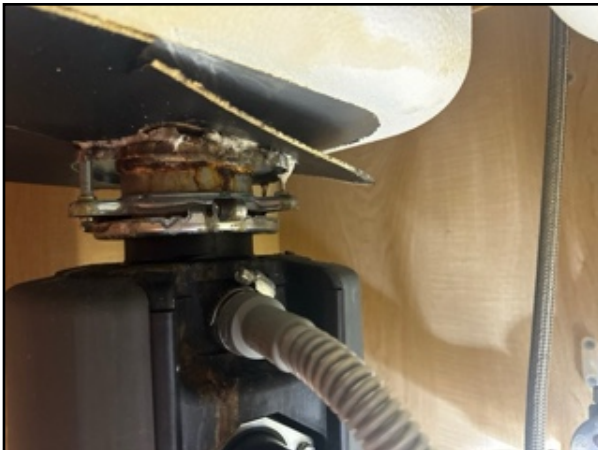
Figure 43-1

Comment 43:  
Active plumbing leak in sink base cabinet.

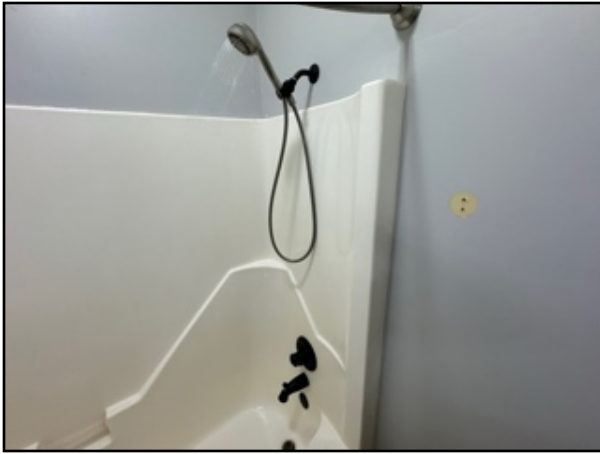
Figure 44-1

Hammering water lines in the wall when hallway bathroom shower is in use.

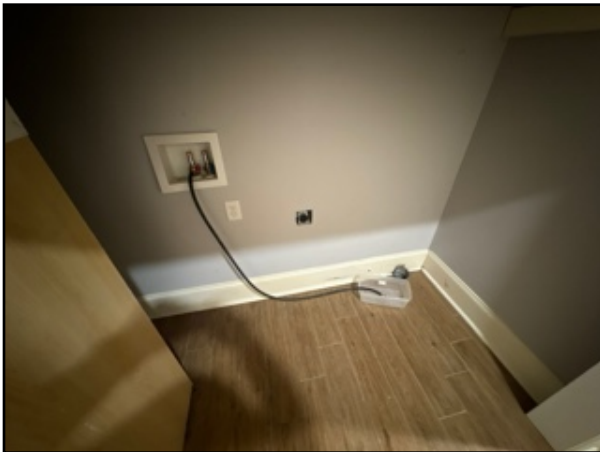
Figure 45-1

Washing machine water valves leaking at the time of inspection.

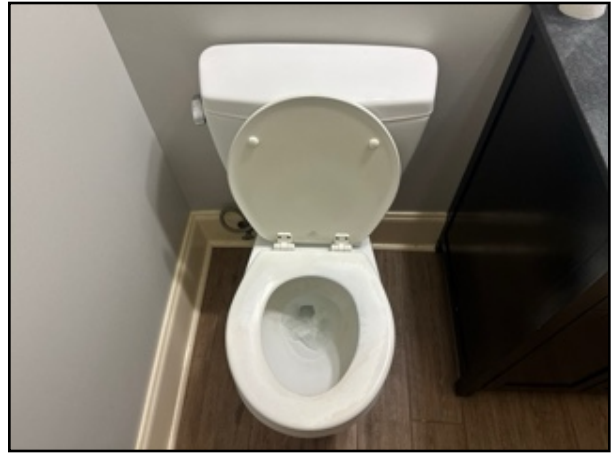
Figure 46-2

The toilet was loose from the floor at the time of inspection. Recommend securing the toilet to the floor and ensuring the toilet is leak free. Primary and half bathroom

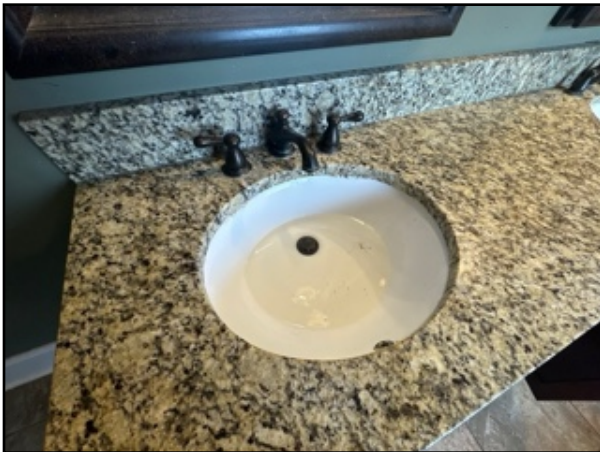
Figure 47-1

Sink draining water slowly at time of inspection. Primary bathroom

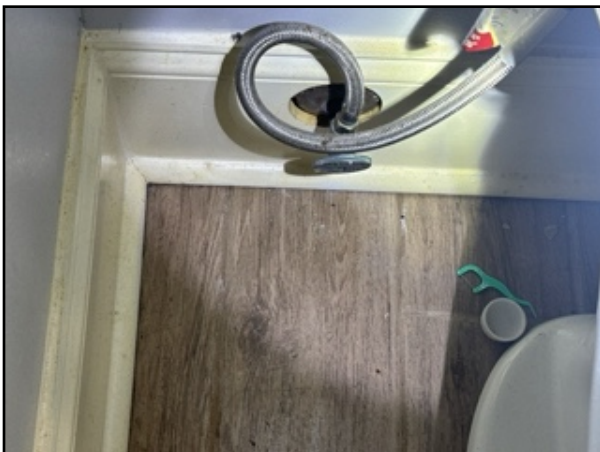
Figure 49-1

Active leak from the toilet water valve/supply line in the bathroom. Half and upstairs right bathrooms

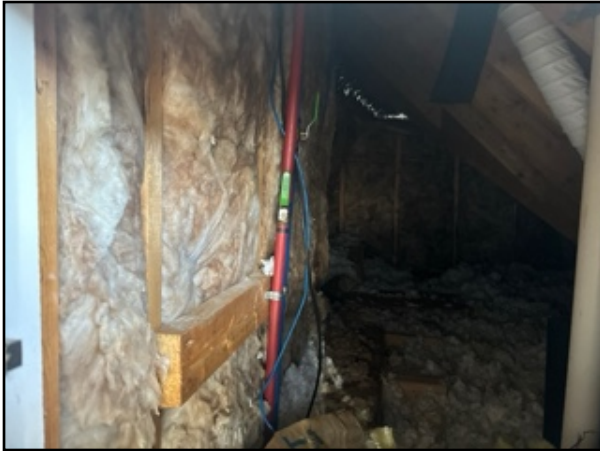
Figure 50-1

Exposed water lines in the attic that where not insulated. Front right and right side attic areas

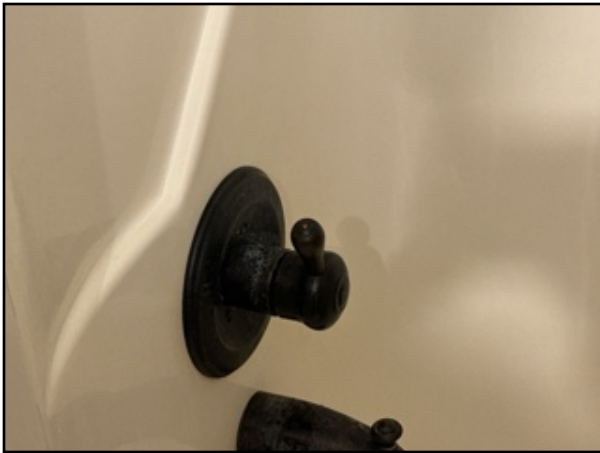
Figure 54-1

The shower valve is not functioning properly. Possibly a valve or handle issue.  
Upstairs left bathroom

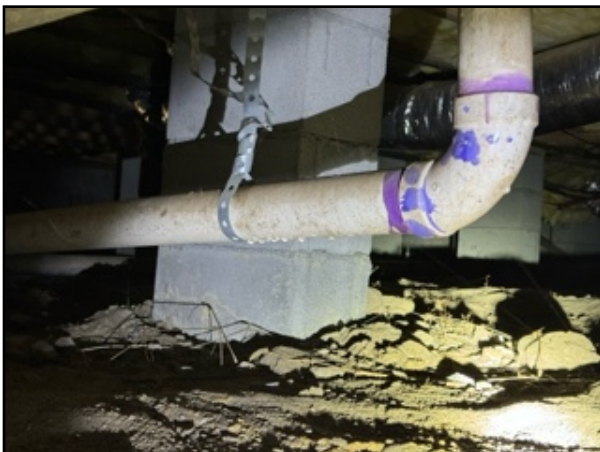
Figure 55-1

Active leak from a drain line under the kitchen area in the crawlspace.

For all items mentioned in this section of the report I recommend evaluation and repair by a licensed plumbing contractor.

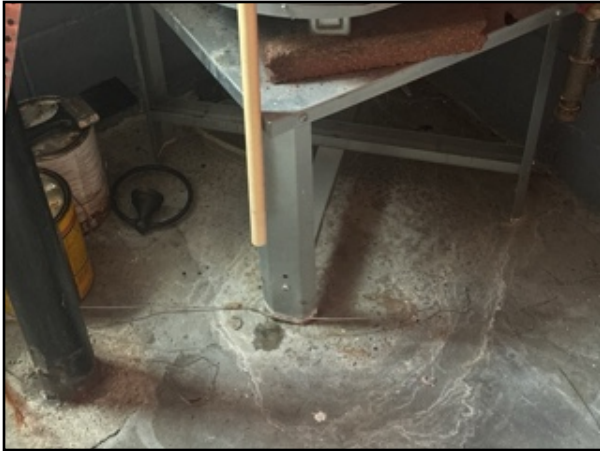
Figure 57-1

The T&P valve piping for the hot water heater was leaking indicating a valve issue. Garage

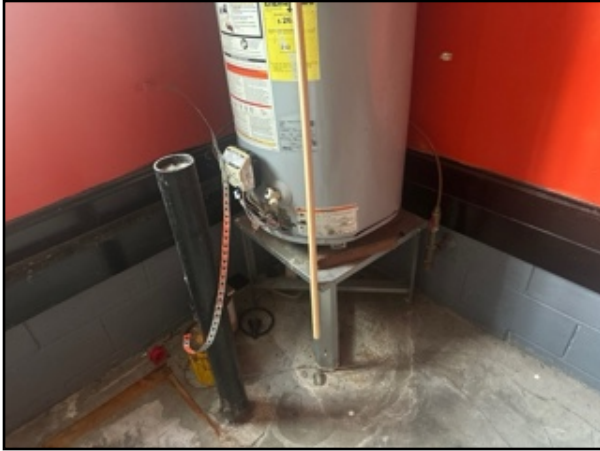
Figure 58-1

There is a detached seismic strap for the water heater. Recommend securing the strap. Garage

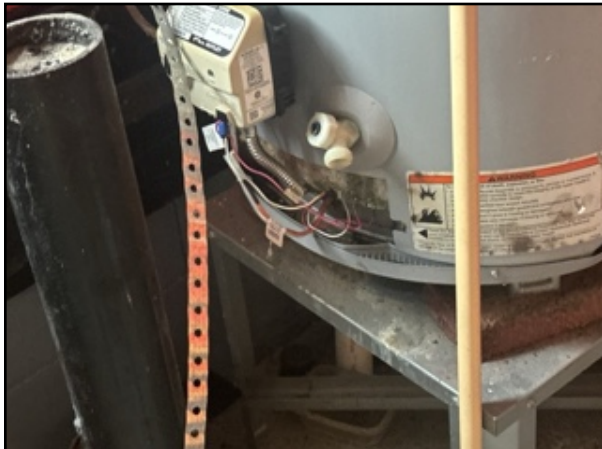
Figure 59-1

The is a cover plate missing for the water heater. Garage

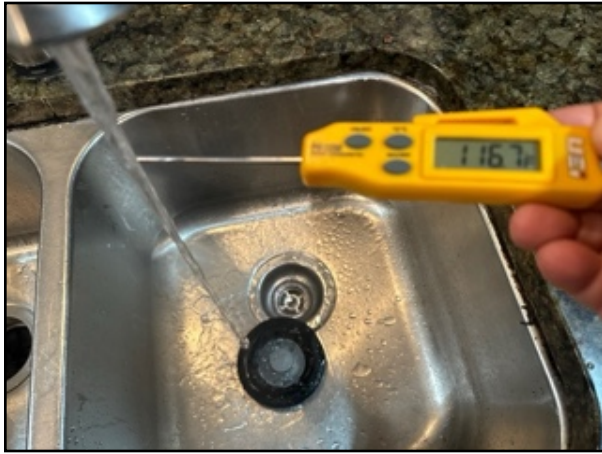
Figure 60-1

Water heater was functioning at the time of inspection.

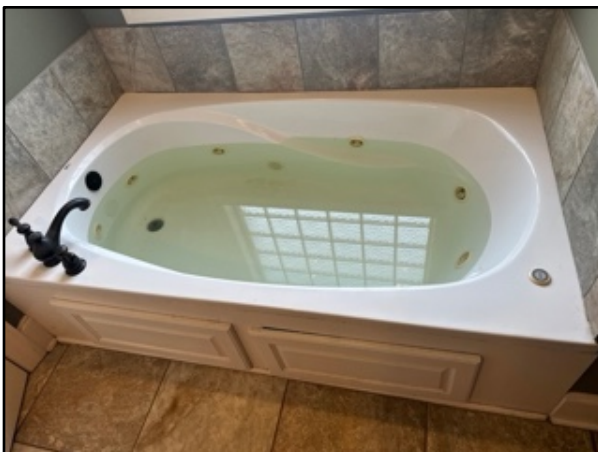
Figure 61-1

The jets did not function for the jet tub in the primary bathroom at the time of inspection. The motor was not plugged in.

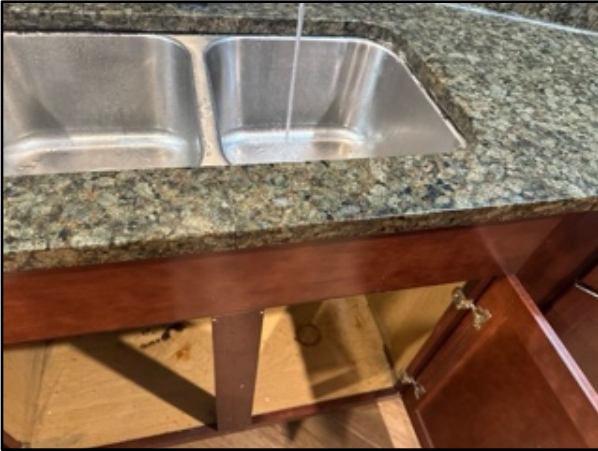
Figure 62-1

The granite counter is loose from the cabinets. Kitchen

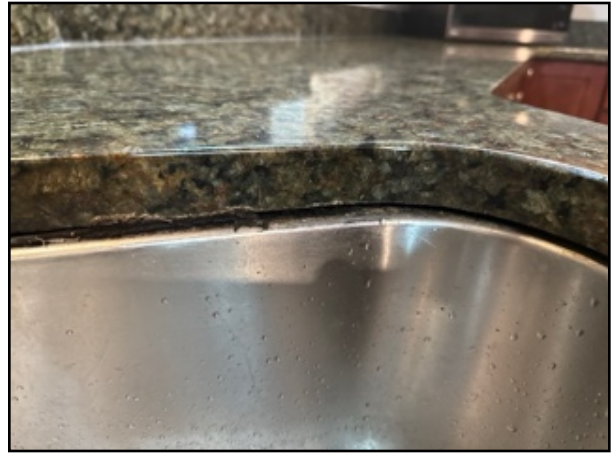
Figure 63-2

The kitchen sink is not secured to the countertop properly and was loose from the countertop. The sink was not sealed to the countertop. Recommend securing and sealing the sink to the countertop.

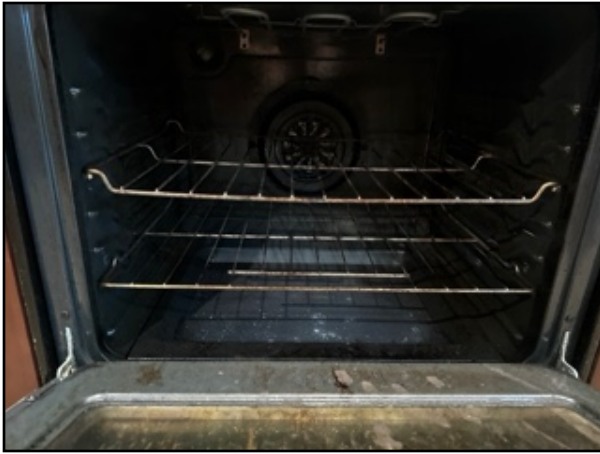
Figure 64-1

Oven light was non-functional. May need a new bulb.

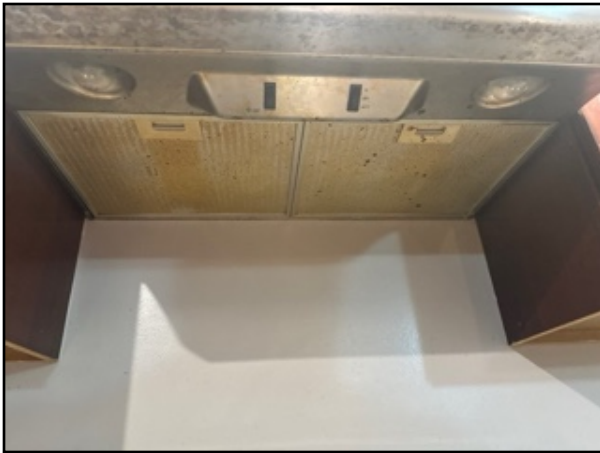
Figure 66-1

The surface light on the bottom of the range hood did not function at the time of inspection. A new bulb may be needed.

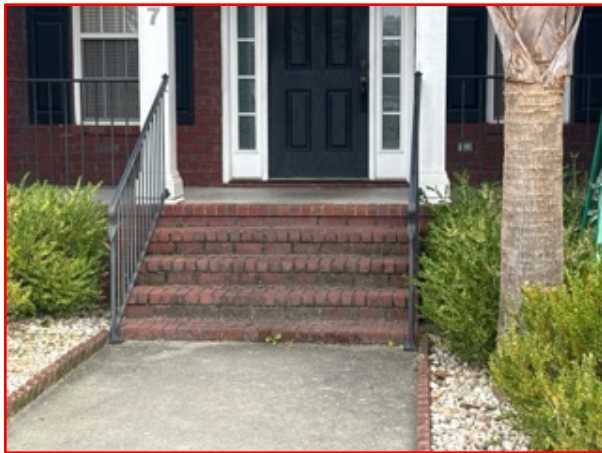
Figure 1-1

1) Comment 1: Loose handrails for entry steps to the home. Exterior front

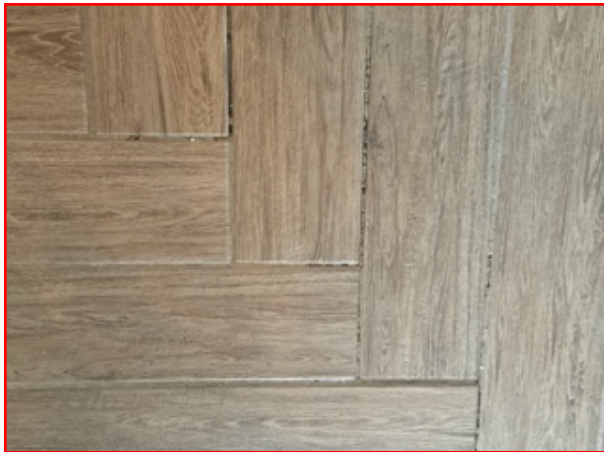
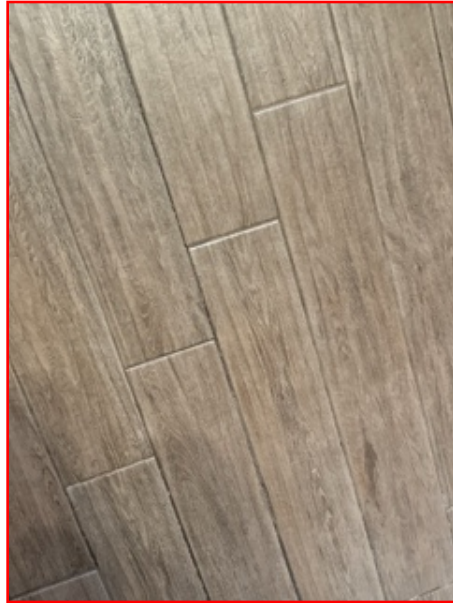
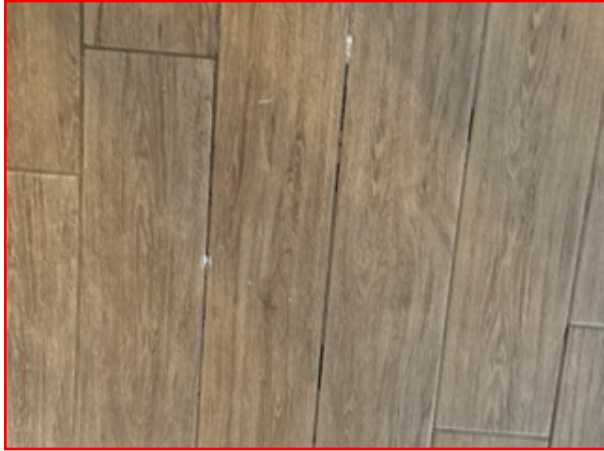
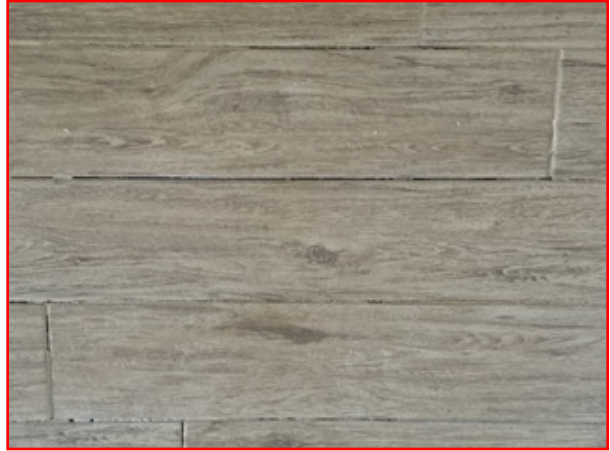
5) Comment 5: Damaged grout for the tile floors scattered inside the home.

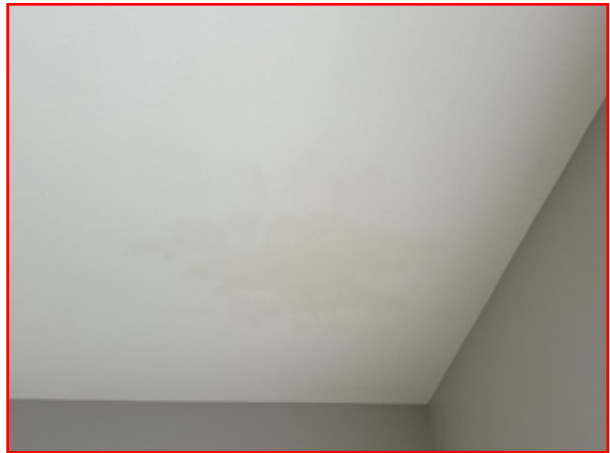
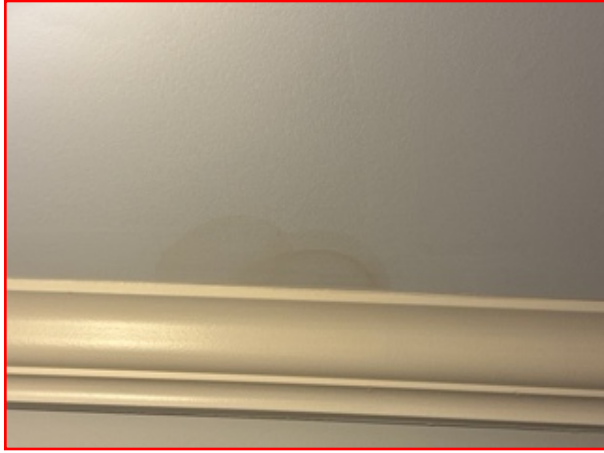
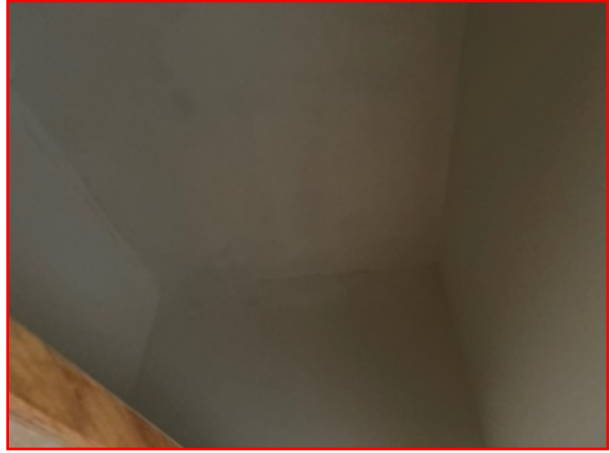
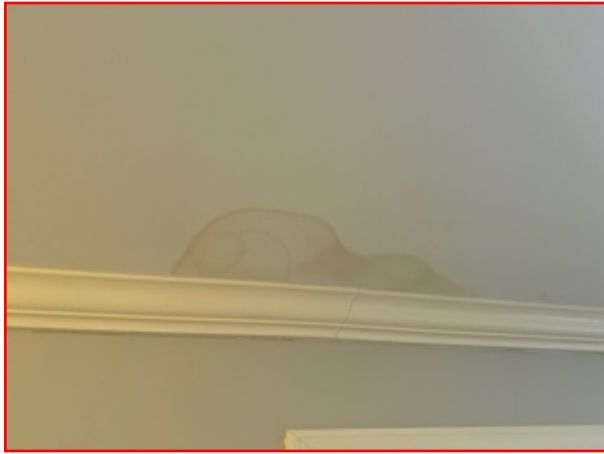
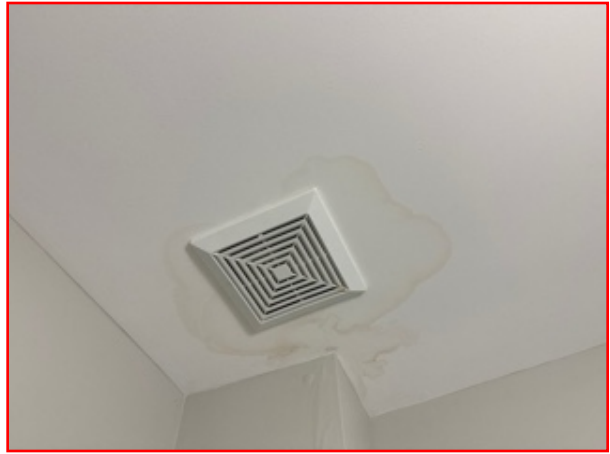
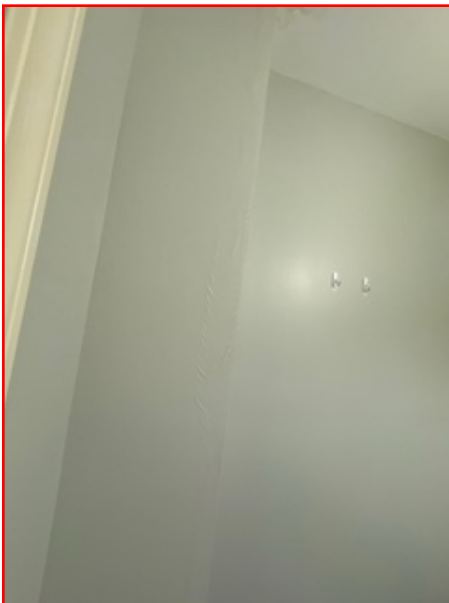
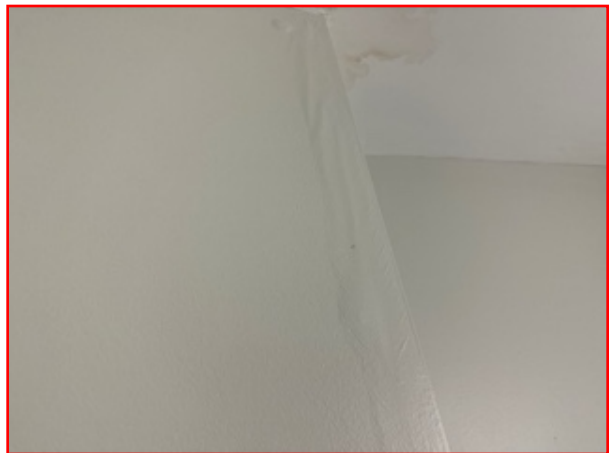
6) Comment 6: Scattered moisture staining to ceilings and walls. Not wet at time of inspection. Recommend further evaluation by a licensed contractor.

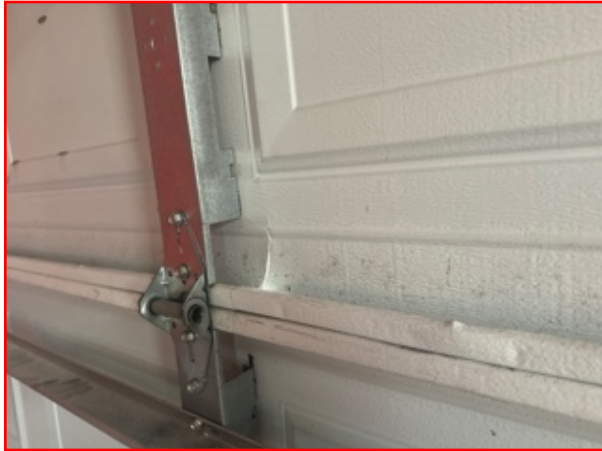
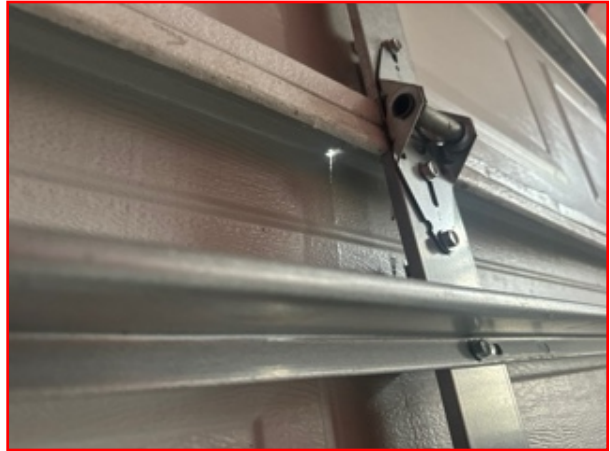
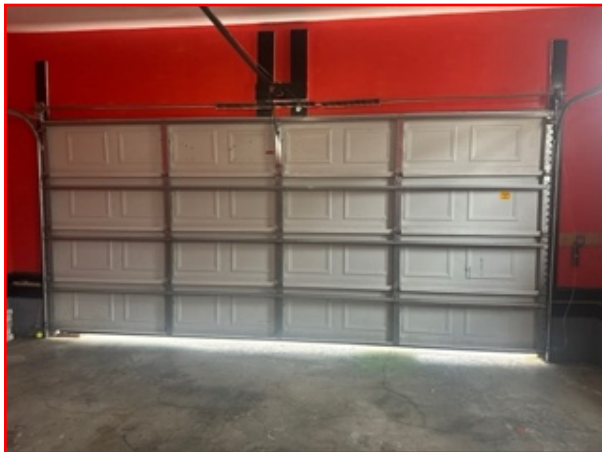
7) Comment 9: Damage to the panels of the garage door. The garage door does not go up fully. Recommend evaluation and repair by a licensed professional.

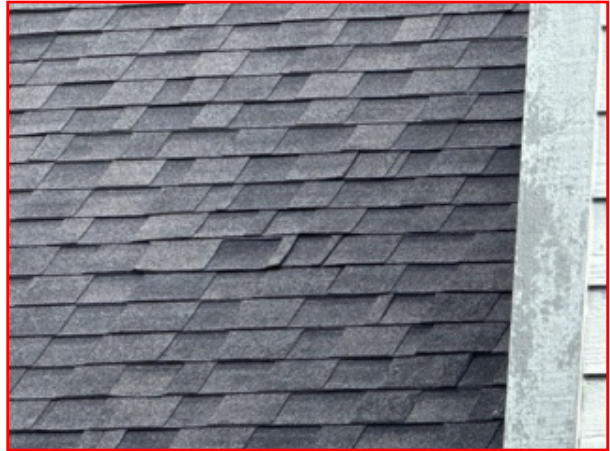
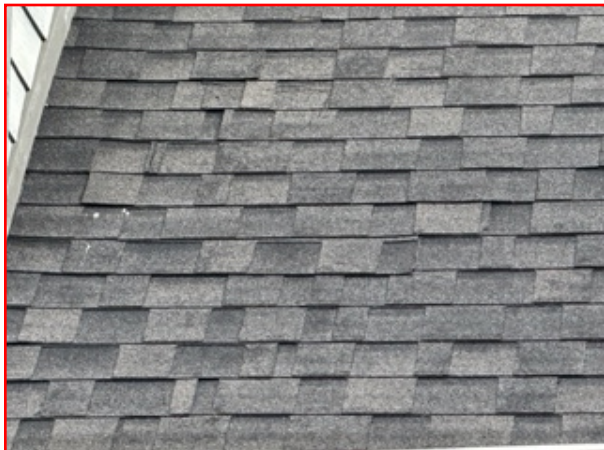
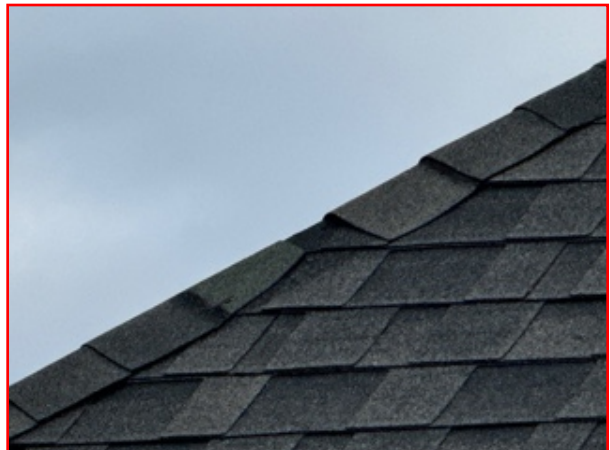
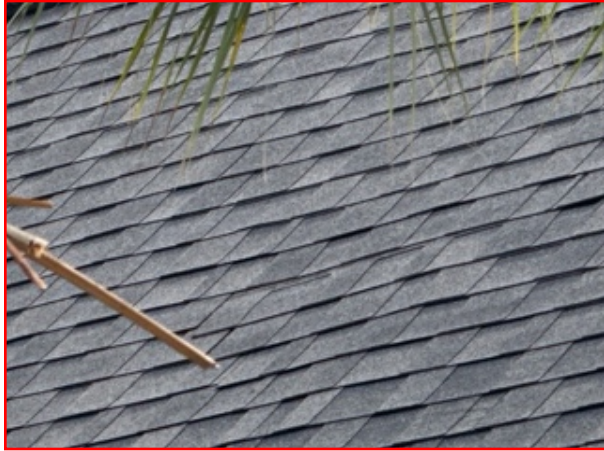
8) Comment 10: Damaged, loose, and/or missing shingles on the roof of the home. There is an area of exposed roof sheathing. Possible hidden damage.

12) Comment 15: Due to the age and amount of issues with the roof I recommend a full evaluation of the roof by a licensed contractor and repair or replace accordingly.
