# Genesis Home Inspections, LLC

## Home Inspection Report

**123 S Main St**

Inspected on Wed, Oct 30 2024 at 9:00AM

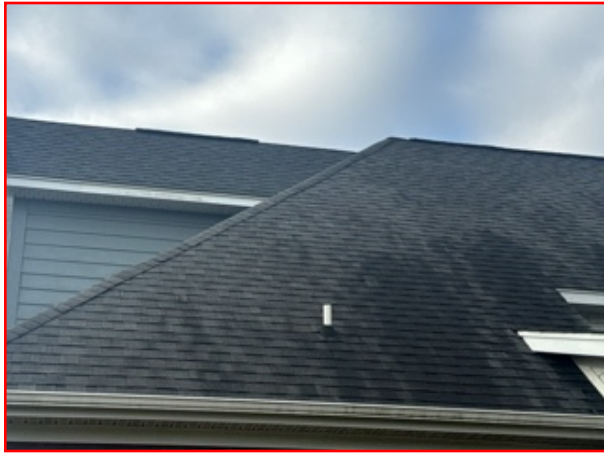
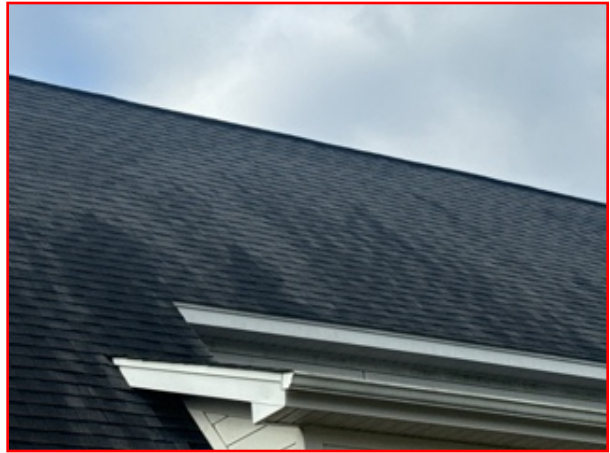
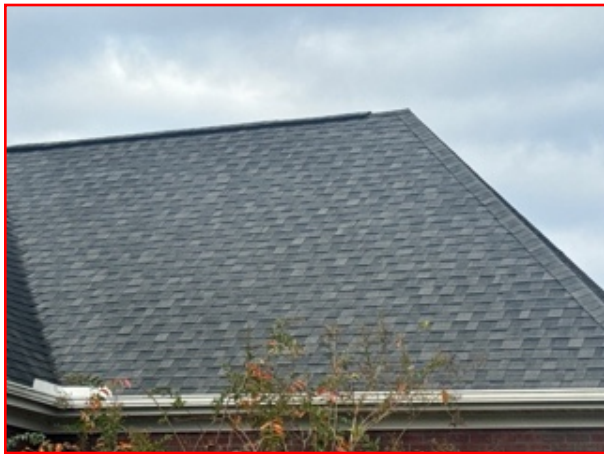
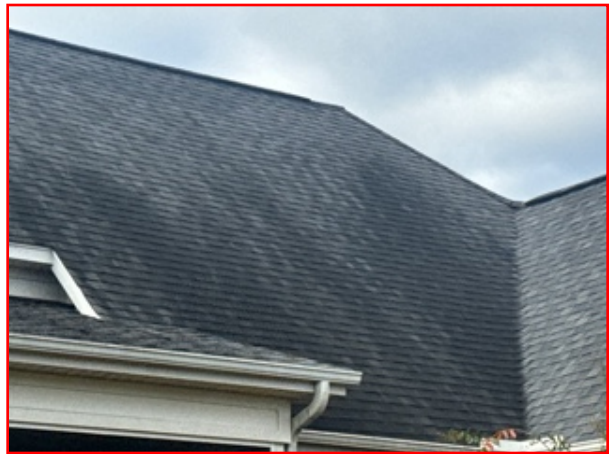
10) Comment 13: Heavy granulation loss to some shingles. The shingles are aged. Recommend evaluation by a licensed roofing contractor.

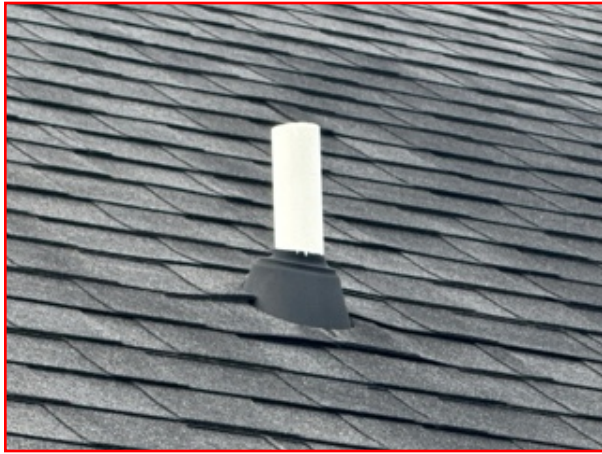
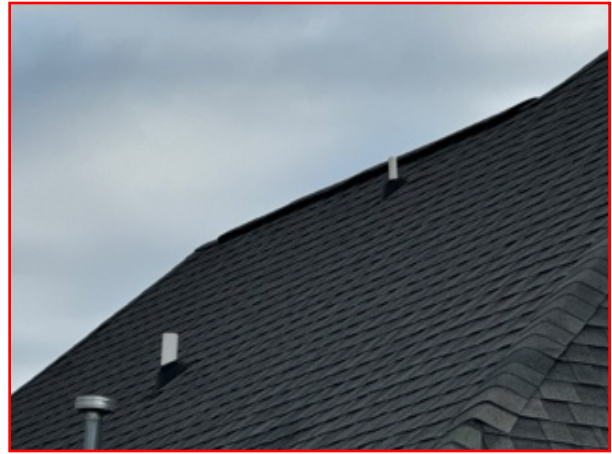
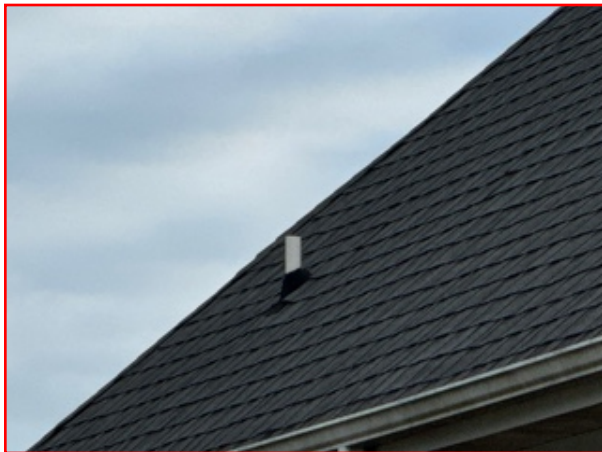
11) Comment 14: Damaged and cracking roof boots. Recommend replacing roof boots.

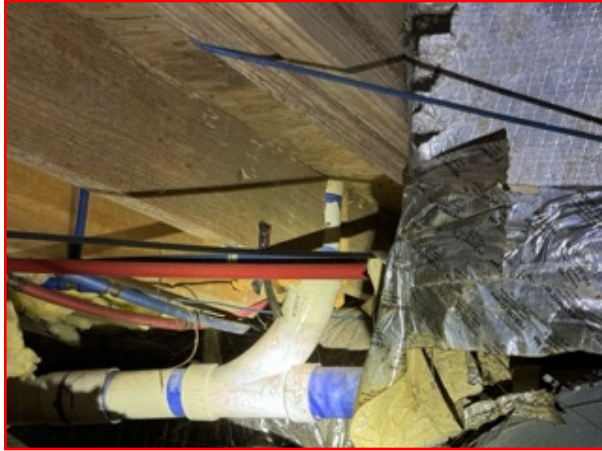
Figure 16-1

13) Comment 16: There is a cut floor joist without repairs in the crawlspace of the home. Recommend evaluation and repair by a licensed contractor. Right center area in the crawlspace.

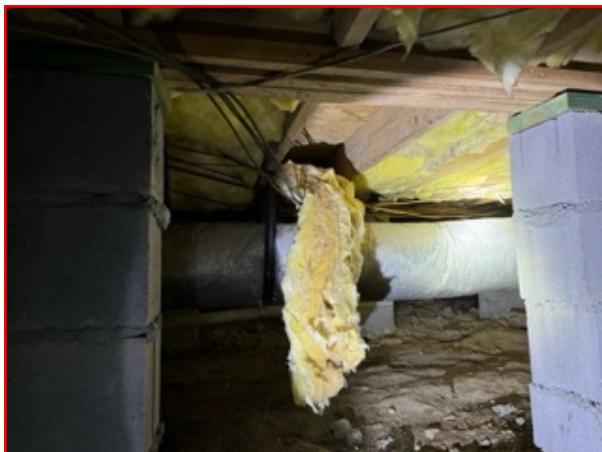
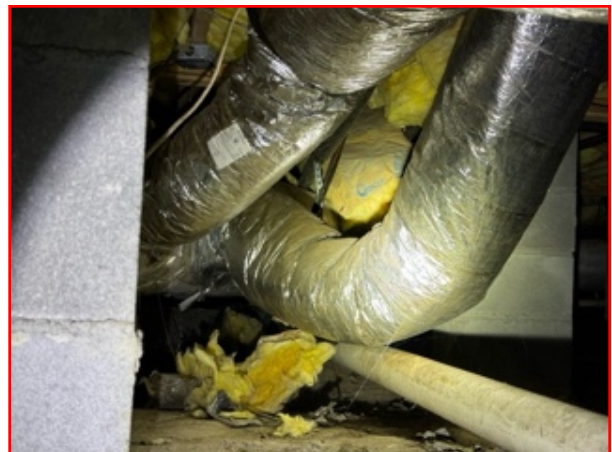
14) Comment 18: Falling and/or missing insulation in crawlspace of home.

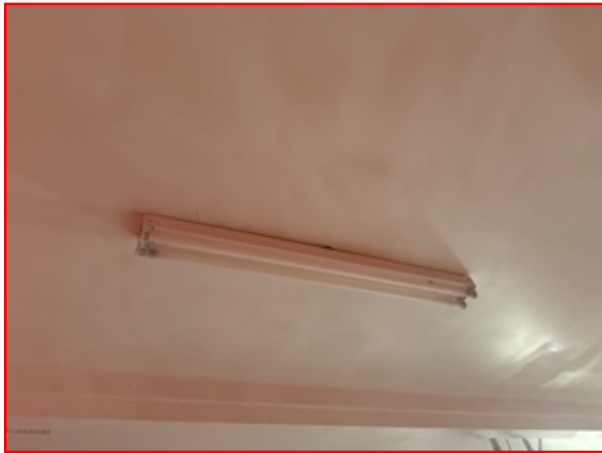
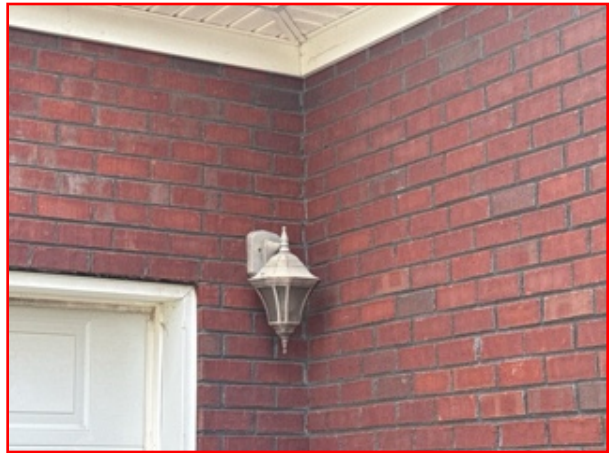
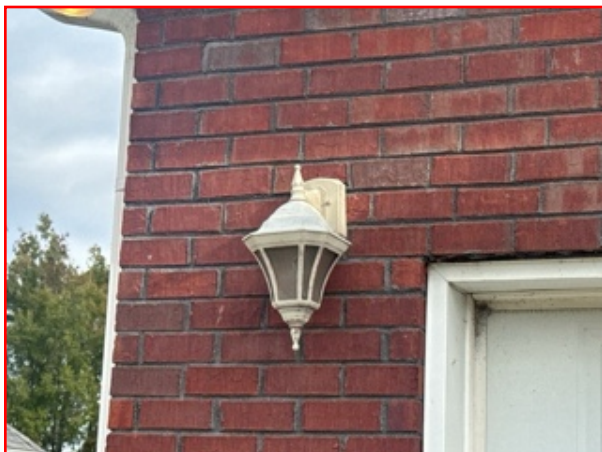
15) Comment 22: Light fixture non-functional at time of inspection. New bulbs may needed. Garage and exterior

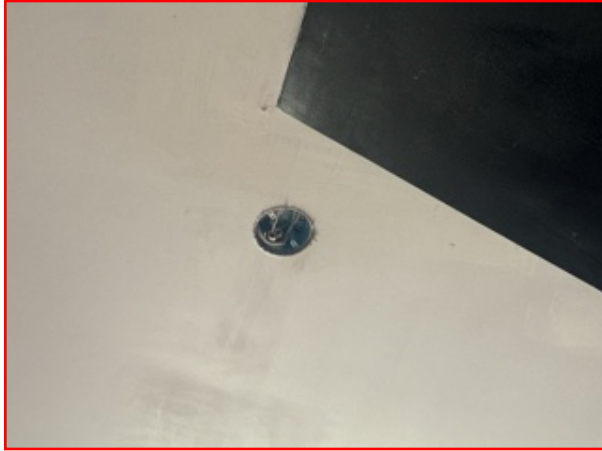
Figure 23-1

16) Comment 23: Open electrical wire in the garage ceiling. It appears the fixture is missing. Recommend installing a fixture.

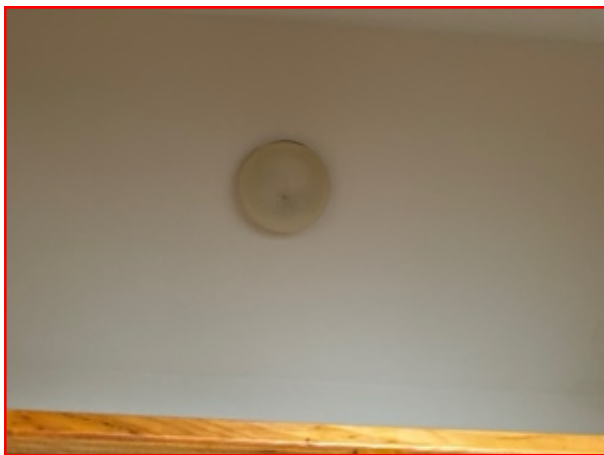
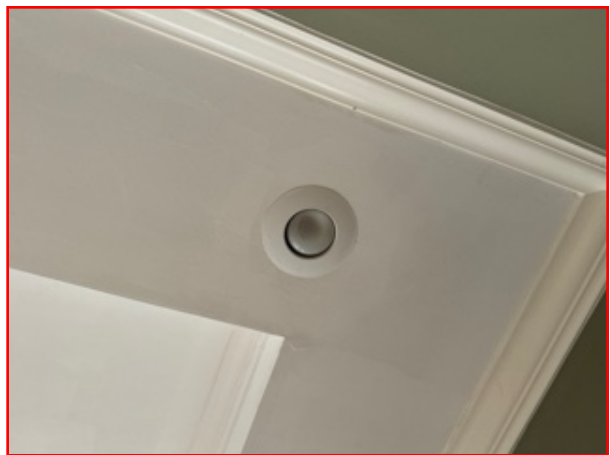
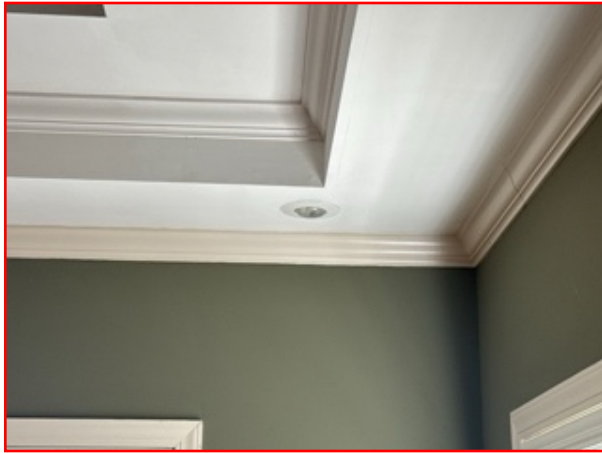
19) Comment 26: Light fixture non-functional at time of inspection. New bulbs may needed. Right center bedroom closet and primary bedroom

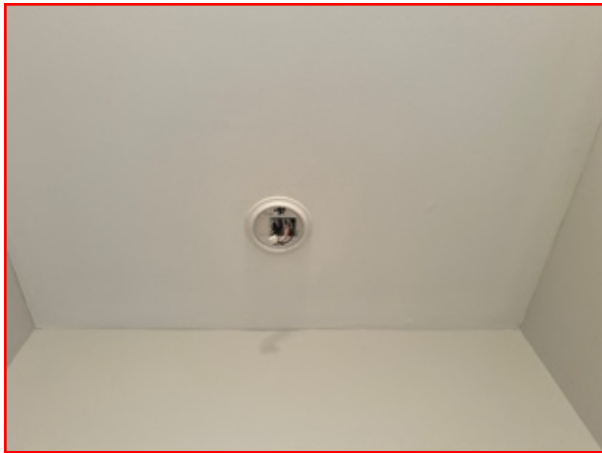
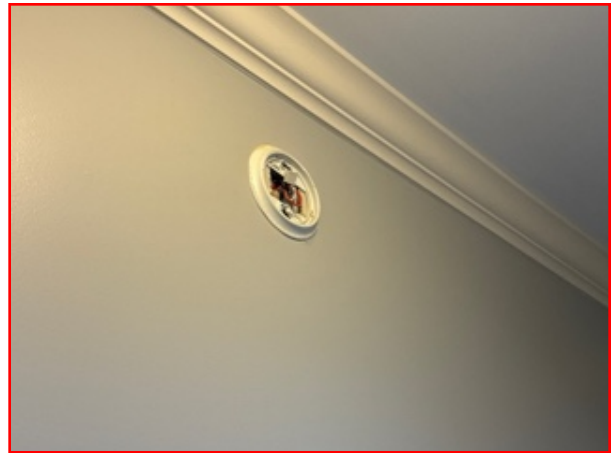
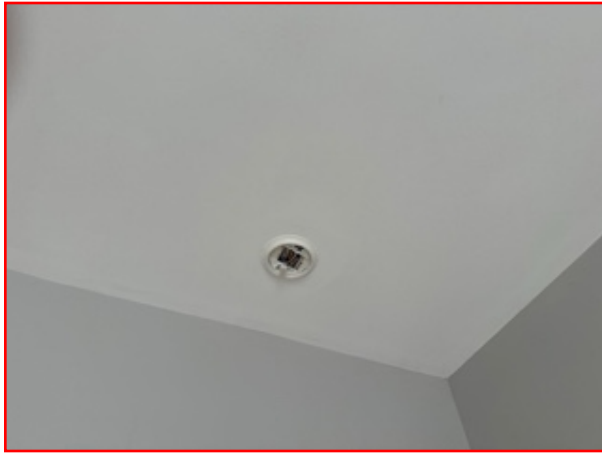
20) Comment 27: Smoke detectors missing from some bedrooms and hallways. Recommend installing smoke detectors where needed.

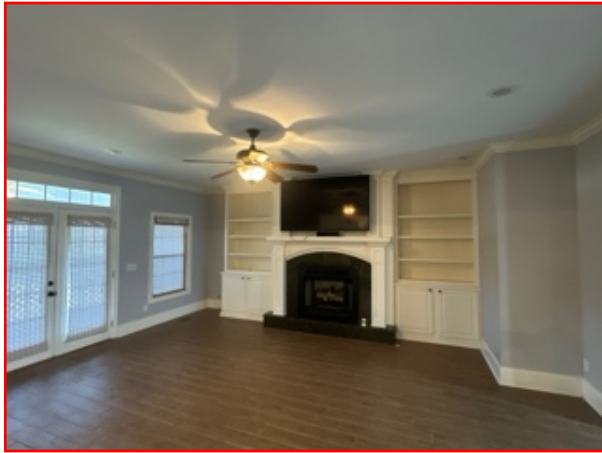
Figure 28-1

21) Comment 28: There are gas appliances in the home and there is not a carbon monoxide detector present. Recommend installing a carbon monoxide detector.

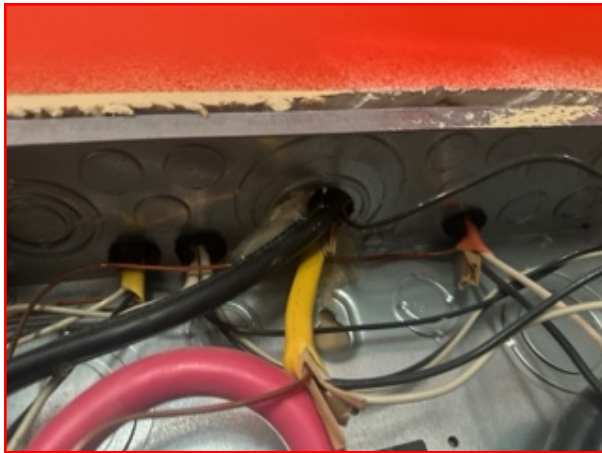
Figure 30-1

22) Comment 30: Electrical wires entering panel not protected by strain relief (romex connector). Recommend installing strain relief. Garage

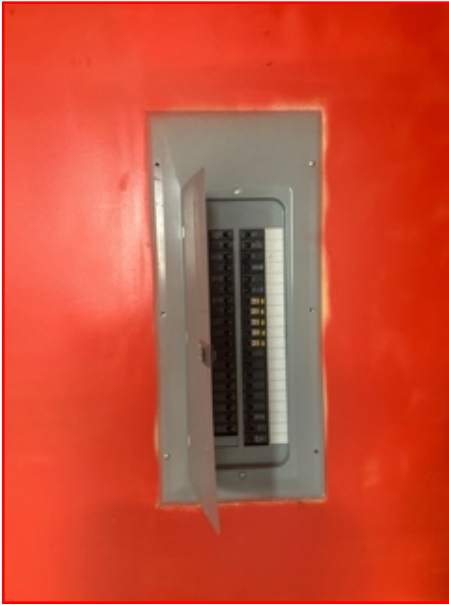
Figure 31-1

23) Comment 31: There are screws missing from panel cover. Recommend installing panel cover screws where needed. Garage

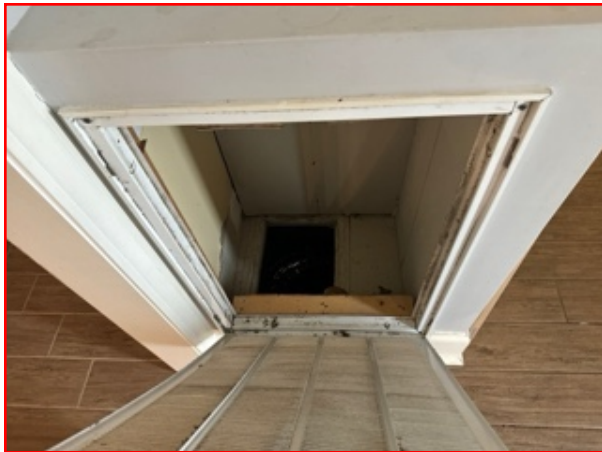
Figure 32-1

24) Comment 32: The HVAC air filter was missing at time of inspection. Recommend changing the filters monthly.

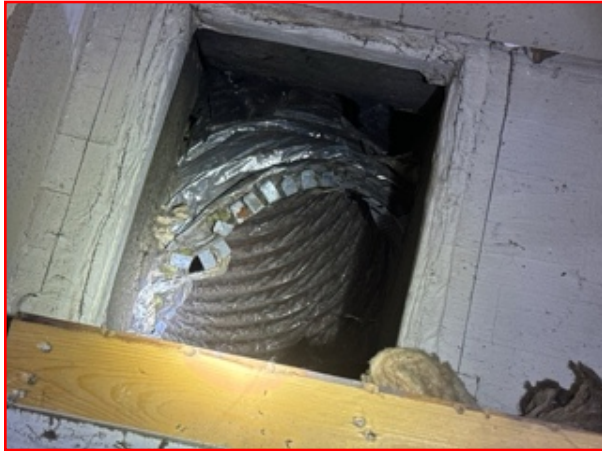
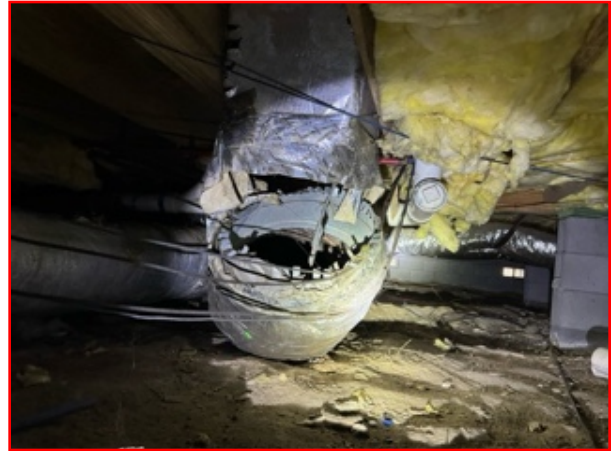
25) Comment 33: The return duct for the package unit was disconnected in the crawlspace of the home.

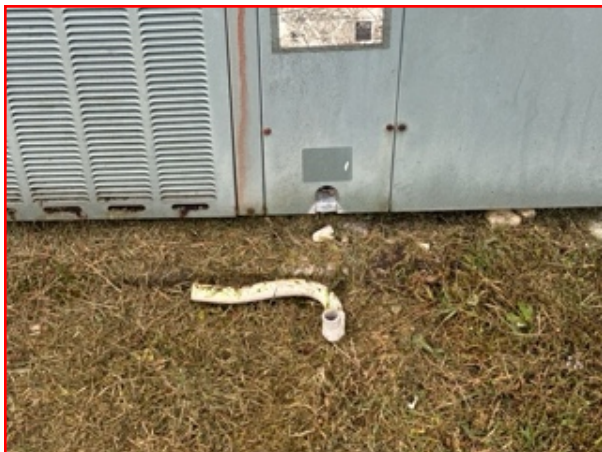
Figure 38-1

26) Comment 38: Damaged and/or missing drain line for the package HVAC unit. Exterior rear

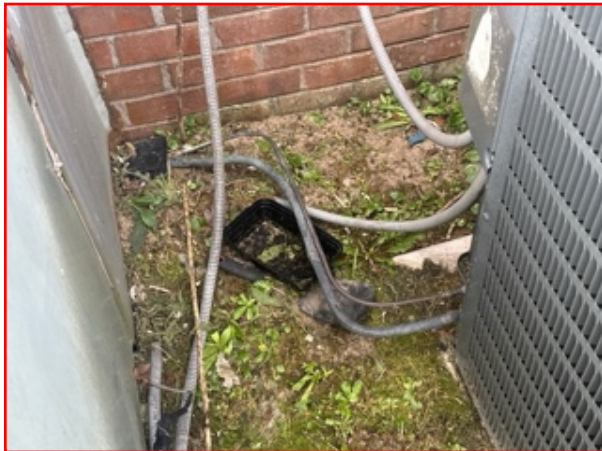
Figure 40-1

27) Comment 40: Damaged and/or missing pipe insulation for the refrigerant line to the HVAC unit. Exterior rear

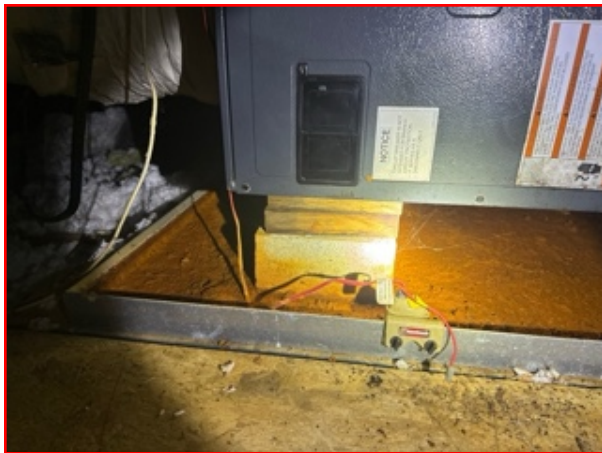
Figure 42-1

28) Comment 42: Drain pan for the air handler in the attic had heavy rust. Recommend evaluation and repair if necessary by a licensed HVAC contractor. Upper attic

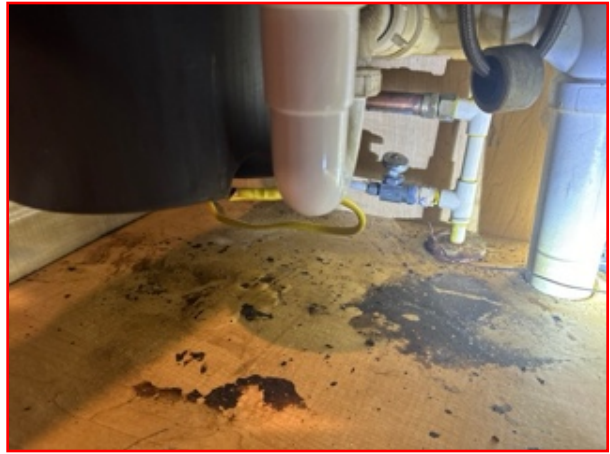
Figure 43-2

29) Comment 43: Active plumbing leak in sink base cabinet.

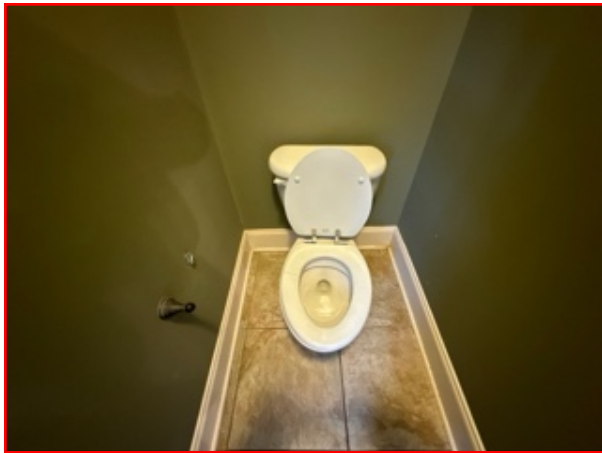
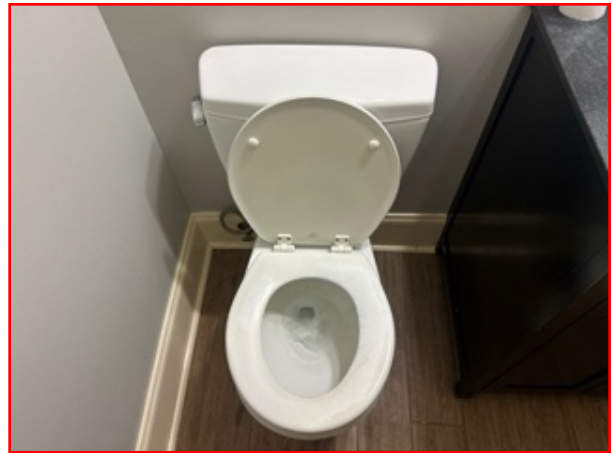
32) Comment 46: The toilet was loose from the floor at the time of inspection. Recommend securing the toilet to the floor and ensuring the toilet is leak free. Primary and half bathroom

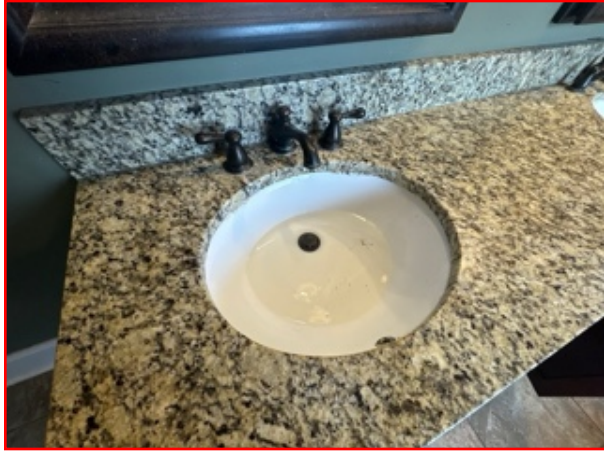
Figure 47-1

33) Comment 47: Sink draining water slowly at time of inspection. Primary bathroom

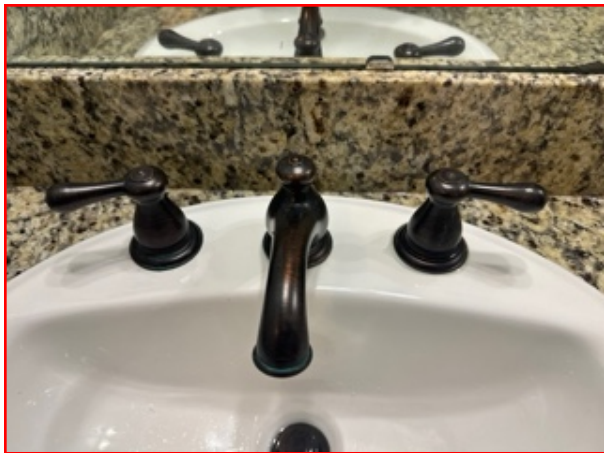
Figure 48-1

34) Comment 48: Sink faucet leaks from base and/or handles. Hallway bathroom

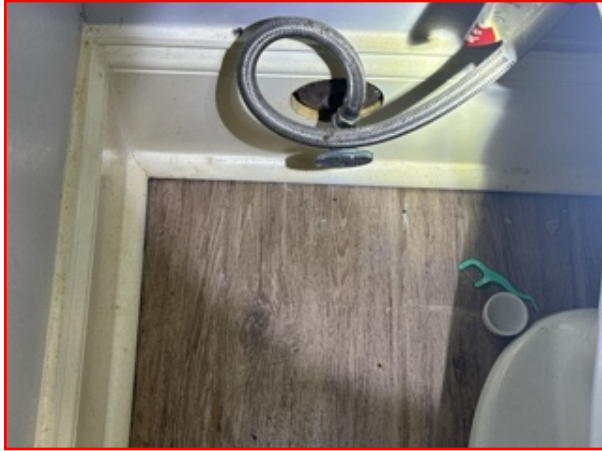
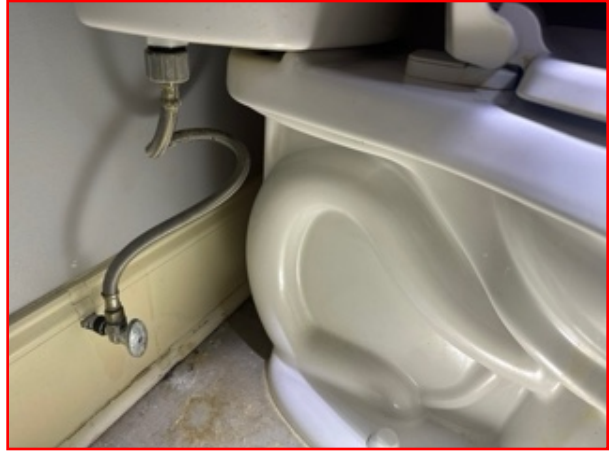
35) Comment 49: Active leak from the toilet water valve/supply line in the bathroom. Half and upstairs right bathrooms

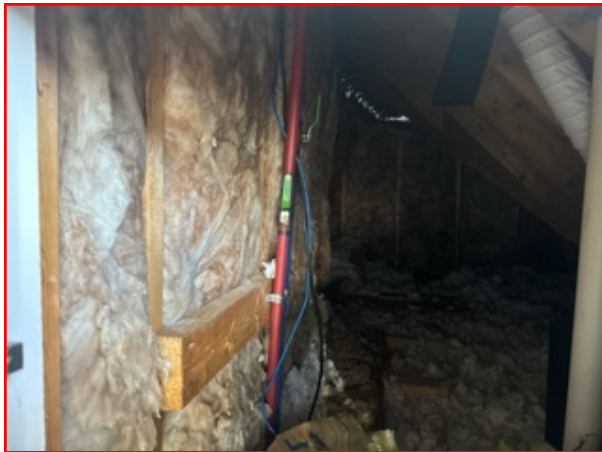
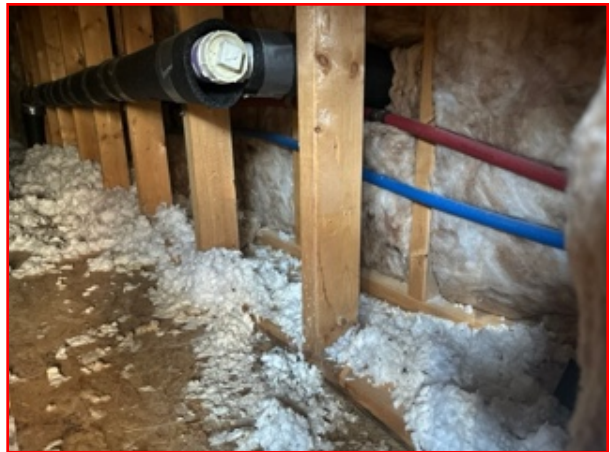
36) Comment 50: Exposed water lines in the attic that where not insulated. Front right and right side attic areas

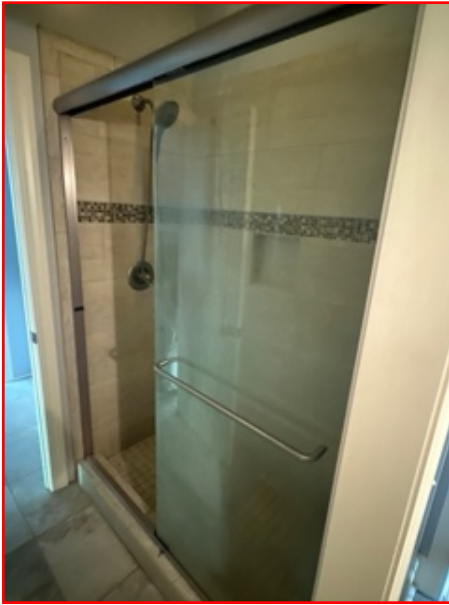
Figure 51-1

37) Comment 51: There is one door missing for the tile shower. Upstairs right bathroom

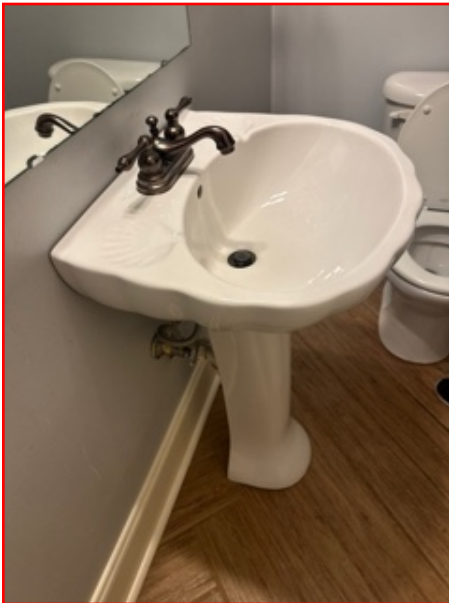
Figure 52-1

38) Comment 52: Pedestal sink is loose from the wall. Recommend securing to the wall. Upstairs left bathroom

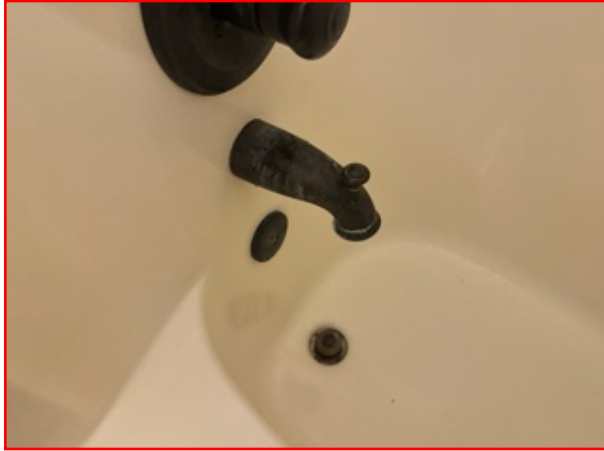
Figure 53-1

39) Comment 53: The tub spout is not sealed to the shower wall. Recommend sealing to prevent moisture penetration behind the tub spout. Upstairs left bathroom

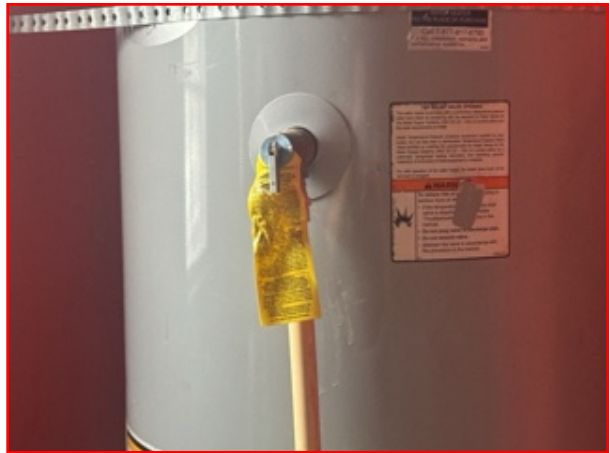
Figure 57-2

The T&P valve piping for the hot water heater was leaking indicating a valve issue. Garage

42) Comment 57: The T&P valve piping for the hot water heater was leaking indicating a valve issue. Garage

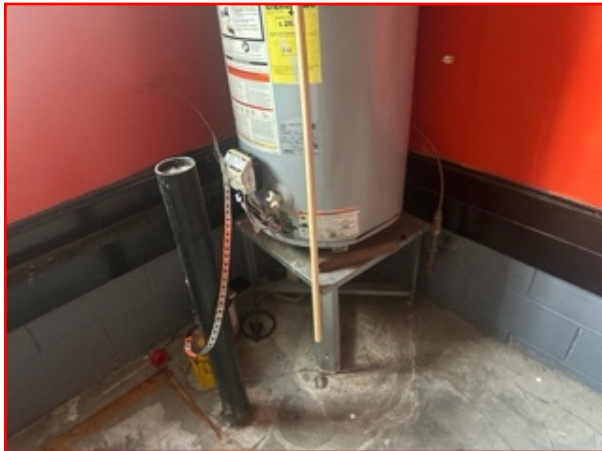
Figure 58-1

There is a detached seismic strap for the water heater. Recommend securing the strap. Garage

43) Comment 58: There is a detached seismic strap for the water heater. Recommend securing the strap. Garage

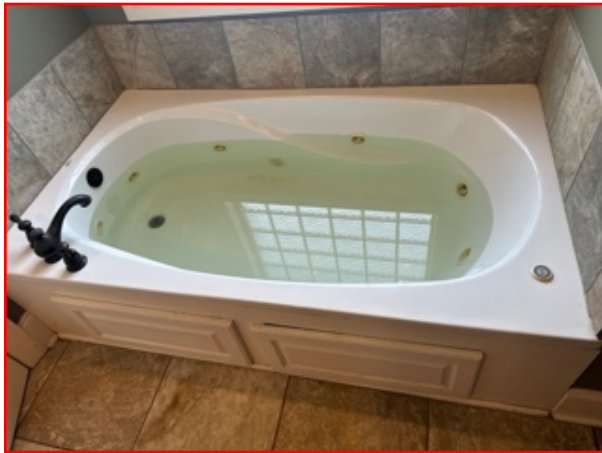
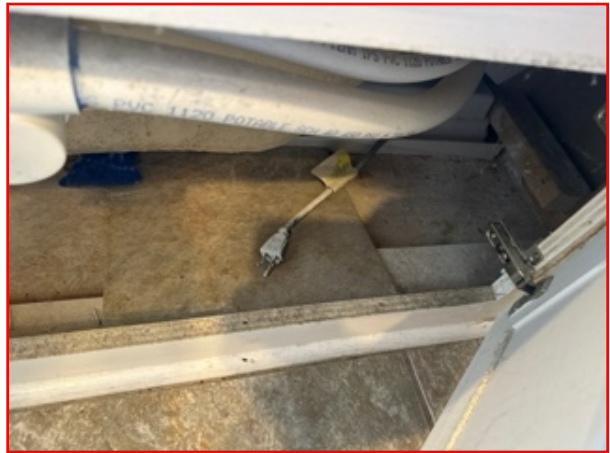
45) Comment 61: The jets did not function for the jet tub in the primary bathroom at the time of inspection. The motor was not plugged in.

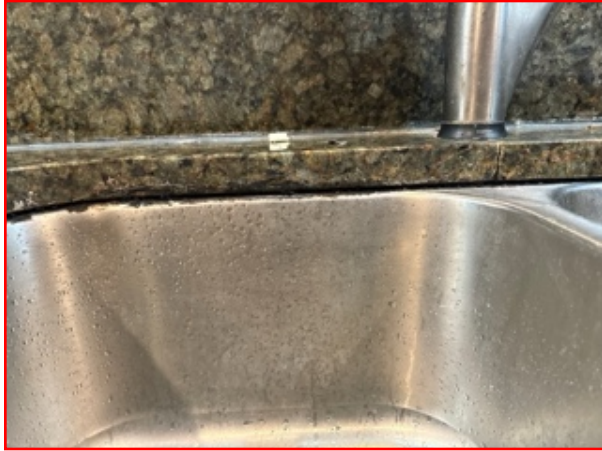
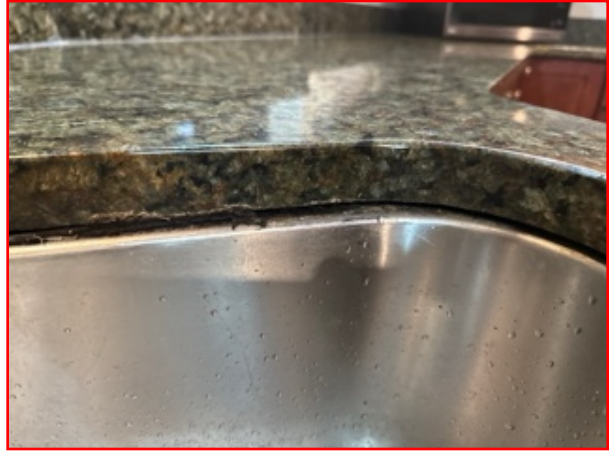
The kitchen sink is not secured to the countertop properly and was loose from the countertop. The sink was not sealed to the countertop. Recommend securing and sealing the sink to the countertop.

47) Comment 63: The kitchen sink is not secured to the countertop properly and was loose from the countertop. The sink was not sealed to the countertop. Recommend securing and sealing the sink to the countertop.

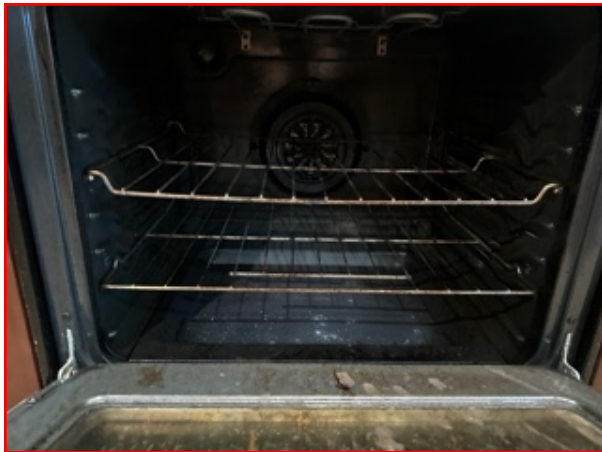
Figure 64-1

48) Comment 64: Oven light was non-functional. May need a new bulb.

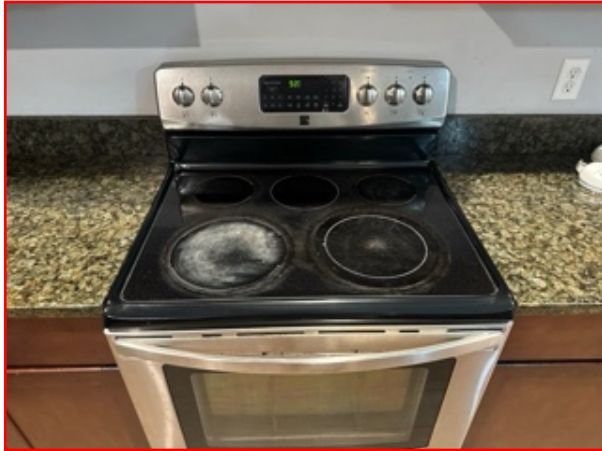
Figure 65-1

No anti-tip bracket installed for range at time of inspection. Recommend installing anti-tip bracket.

49) Comment 65: No anti-tip bracket installed for range at time of inspection. Recommend installing anti-tip bracket.

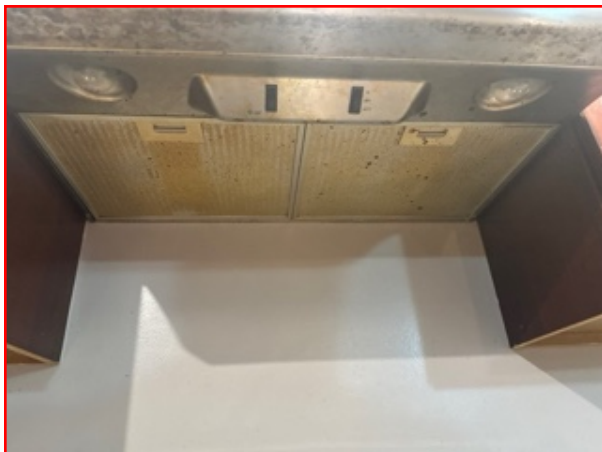
Figure 66-1

50) Comment 66: The surface light on the bottom of the range hood did not function at the time of inspection. A new bulb may be needed.

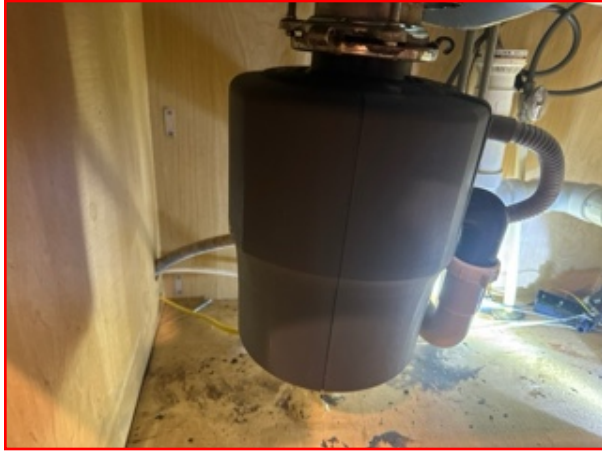
Figure 67-1

There was no visible elevated drip loop for the dishwasher drain line under the kitchen sink. Recommend installing an elevated drip loop for the dishwasher drain line.

51) Comment 67: There was no visible elevated drip loop for the dishwasher drain line under the kitchen sink. Recommend installing an elevated drip loop for the dishwasher drain line.

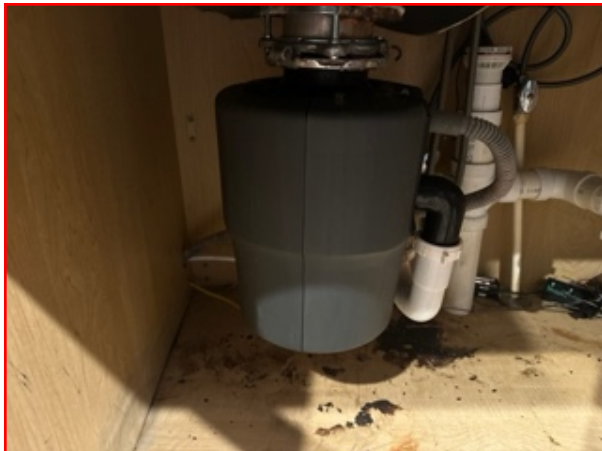
Figure 68-1

A foreign object was in the disposal at the time of inspection. Recommend removal of the foreign object.

52) Comment 68: A foreign object was in the disposal at the time of inspection. Recommend removal of the foreign object.

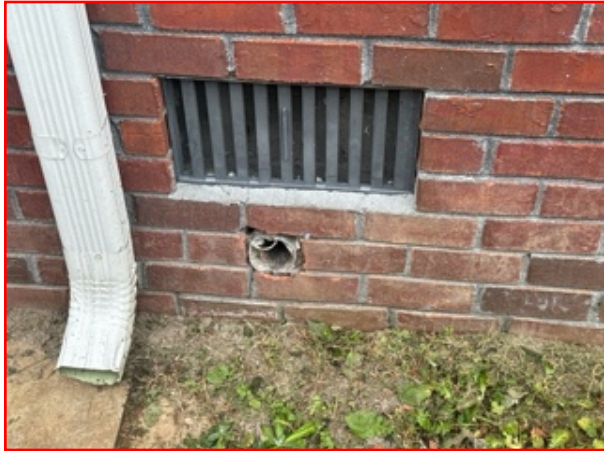
Figure 69-1

Exterior dryer vent hood is damaged and/or missing. Recommend installing an exterior dryer vent hood. Exterior left side

53) Comment 69: Exterior dryer vent hood is damaged and/or missing. Recommend installing an exterior dryer vent hood. Exterior left side
